**Wiltshire Archaeological and Natural History Society
Archaeology Field Group**

**Report of Survey of Barn Ground Barn,
Bottom Farm, Malmesbury, Wilts.**

April 2007

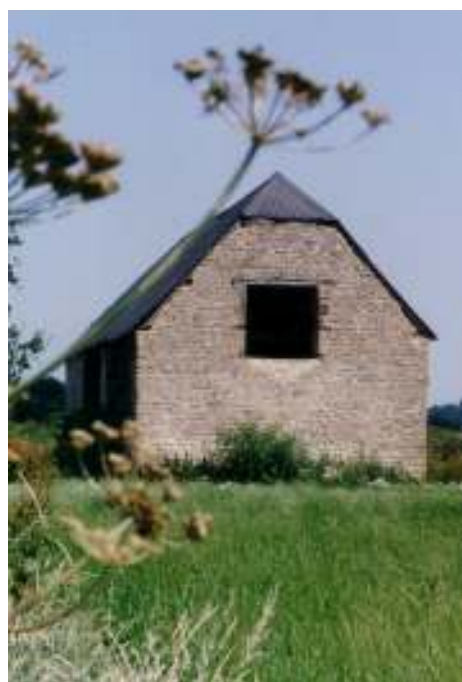
Figure 4. Barn Ground Barn, southern aspect, July 1989 (© Christina Staff).

The barn probably dates to the first half of 19th century and is now considered a remote barn, but it may once have been part of an outlying farmstead. Constructed from course rubble, oolitic limestone, possibly from a quarry on the same estate such as that at ST 928 826. The northern side of the western aspect has a course of cut stone blocks at ground level. Later repairs are of brick and breeze block. It has a rectangular plan with 5 bays and timber lintels. The hipped roof is much repaired with reused timber and is currently covered with galvanised corrugated iron. It is possible that if it was built in the early 1800's it may originally have had an early corrugating iron roof, as corrugating iron is said to have been invented by Henry Palmer (1795-1844) in 1828 (<http://www.corrugated-iron-club-info/iron1.html>). The east facing wall has double plank doors with iron hinges. The brick surround may be a later infill as the doorway on the west side is larger. There is a weatherboard infill to the southern side of the door which is post 1989 (Figures 2 and 3) and a ventilation opening to the northern side of the door. A buttress supports the eastern end of the northern wall. The southern end of the barn is currently in a state of disrepair but had a pitching hole in 1989 (Figure 4.).
