**Wiltshire Archaeological and Natural History Society
Archaeology Field Group**

**Report of Survey of Barns at the Former Bell Farm,
Buckley Barracks, Stanton St Quinton, Wilts.**

Report No. 167.0902

Building Recording of the South and North Barns at Buckley Barracks (formerly a part of Bell Farm, Hullavington).

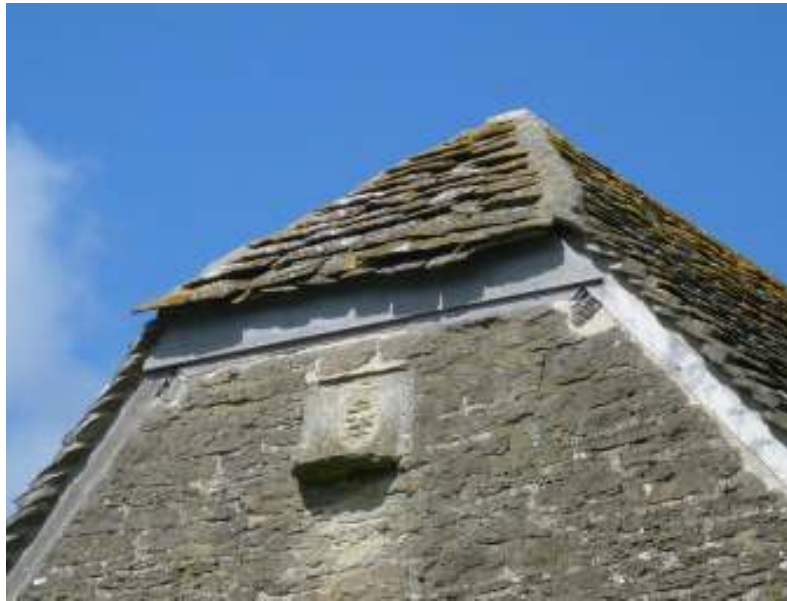
Figure 1. Owl Hole & Perch in South Elevation of South Barn

The five bay barn is constructed of local limestone with fine ashlar quoin stones under a stone tiled half-hipped roof. There were pitching holes at the north and south ends although one has since been blocked with stone, the other now contains a window. There are owl holes with perches on which the owl can alight (Figure 1). This rectangular barn has a porch in the central bay with large doors which are placed opposite each other in the east and west walls. There is a side entrance to the porch which has since been blocked with stone. There are also splayed ventilation holes (Title page and Figures 2-4).

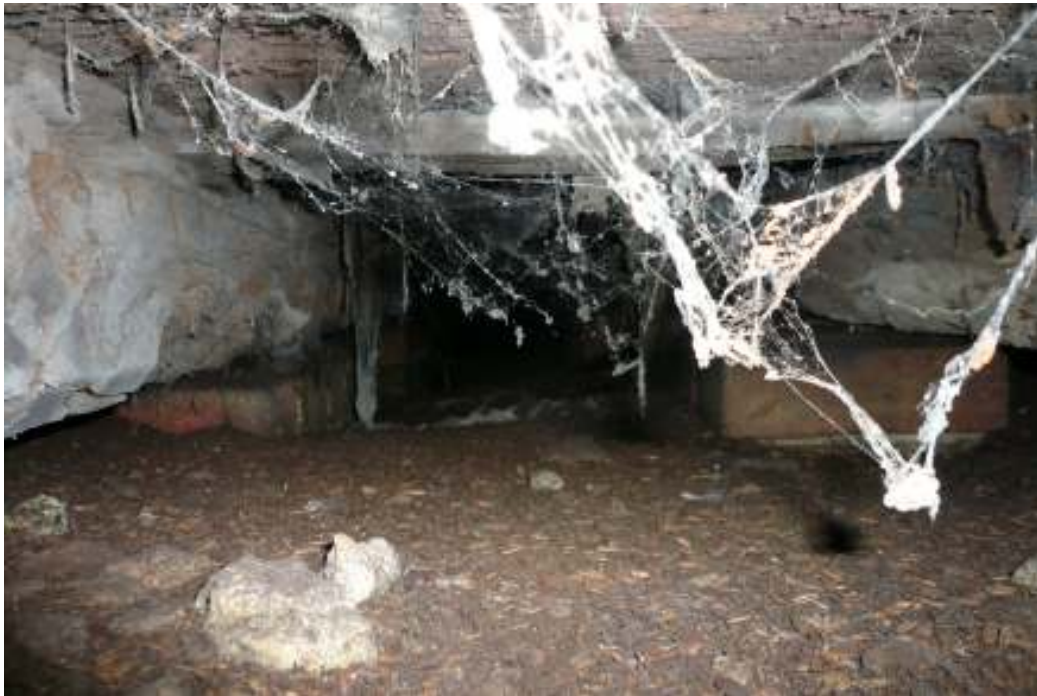
Figure 5. Underneath Threshing Floor of South Barn

The threshing floor is made of 5cm thick oak boards, and whilst subject to repair most of it appears to be original. A board was raised with the permission of the correct authorities to investigate the construction method and to gather a sample of soil from beneath it for analysis. The investigation

revealed that the 5cm oak planking was rested on elm joists which were raised on brick piers. The deposit below the boards, which included chaff, was approximately 27cm in depth. Analysis has shown the chaff was from oats. The raised floor served a dual purpose, firstly to provide ventilation to prevent decay caused by moisture in the stored grain, and secondly to aid rodent prevention - cats and dogs could move freely beneath the floor (Figure 5).

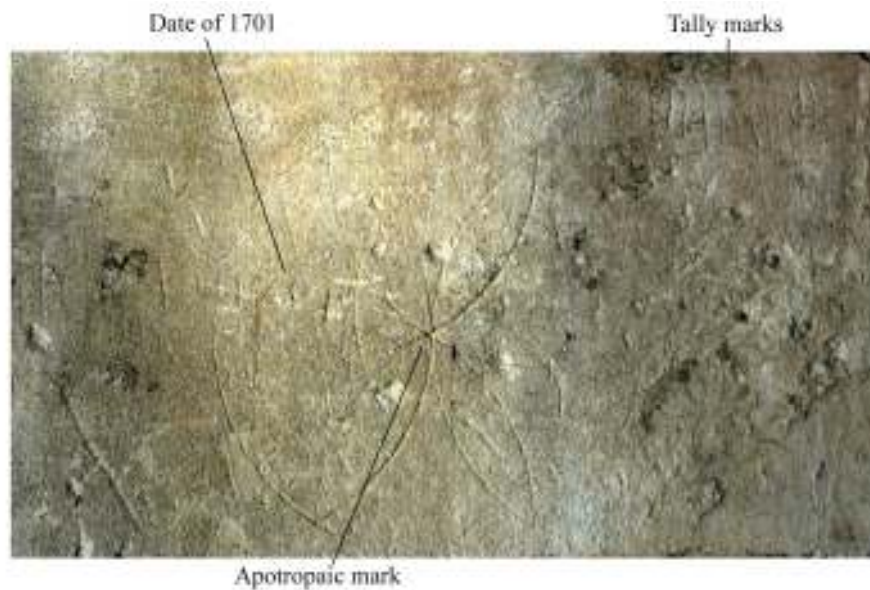
Figure 6. Graffiti on Quoin Outside Blocked Door into Porch

The graffiti in this barn is considerable and consists of names, dates and initials some of which are carved with intricacy. There are also tally marks which are a feature of grain stores and apotropaic marks carved near the doorway, these are said to ward off evil spirits. Graffiti inside the barn dated 1793 appears to be the earliest, whilst others date to as late as 1980. However, on one of the quoins on the outside of the blocked door into the porch there is a possible date of 1701 (Figure 6).

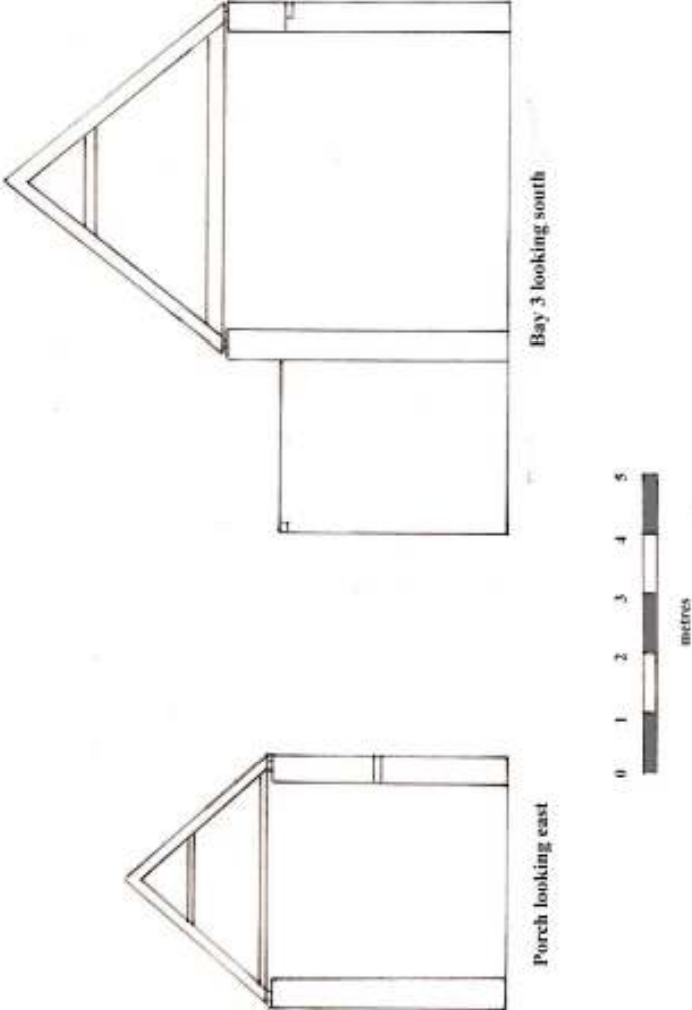
Figure 8. Cross Sections of South Barn

The barn roof is supported by four oak tie beams separating five bays. The roof trusses are a simple A frame with a collar, no struts or posts and with pegged joints at the apex and collar (Figure 8). There are two sets of threaded purlins on each roof face but no wind braces. There are no visible carpenter's marks in this barn.

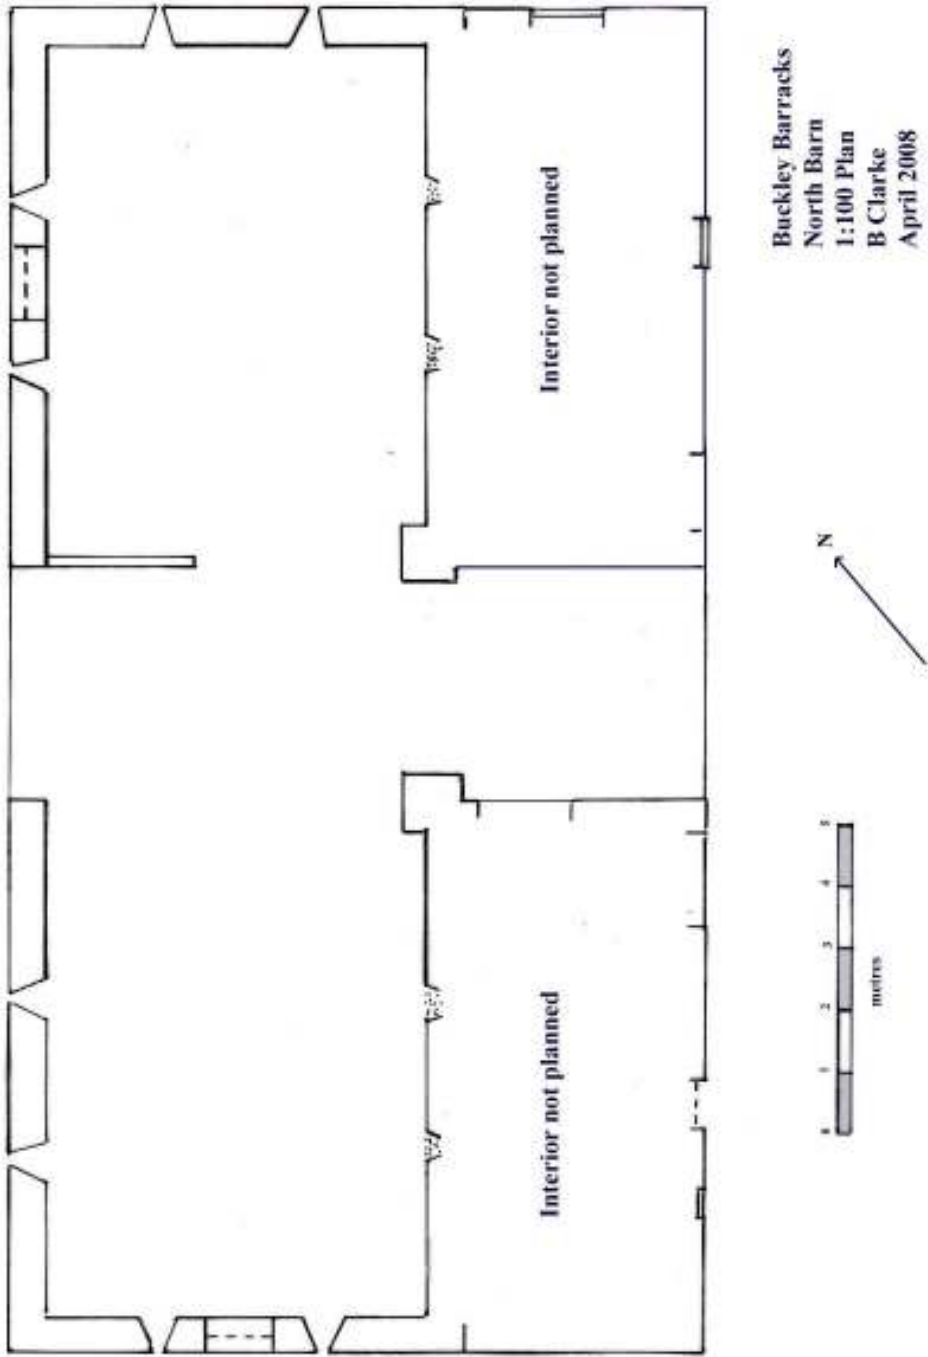
Figure 9. Plan of North Barn

This five bay barn is similar in construction to the South Barn but modified with the addition of rooms either side of the porch (Figures 9 & 10). However in this barn there are carpenter's marks visible in the oak constructed roof. Much less graffiti is visible and a possible reason for this is that this barn was used for storage due to its orientation. A cobbled stone ramp with the tracks of wheels is evident at one entrance to the barn (Figure 13). It is thought that it would have been less suited to threshing than the neighbouring South Barn which has east-west doors that would have favoured the prevailing south-westerly winds.
