The Lost Chapel of Bincknoll, Broad Town,  
North Wiltshire:

An interim report covering the excavations at  
Bincknoll Cottage 2014

Site Report 2014:1

March 2015

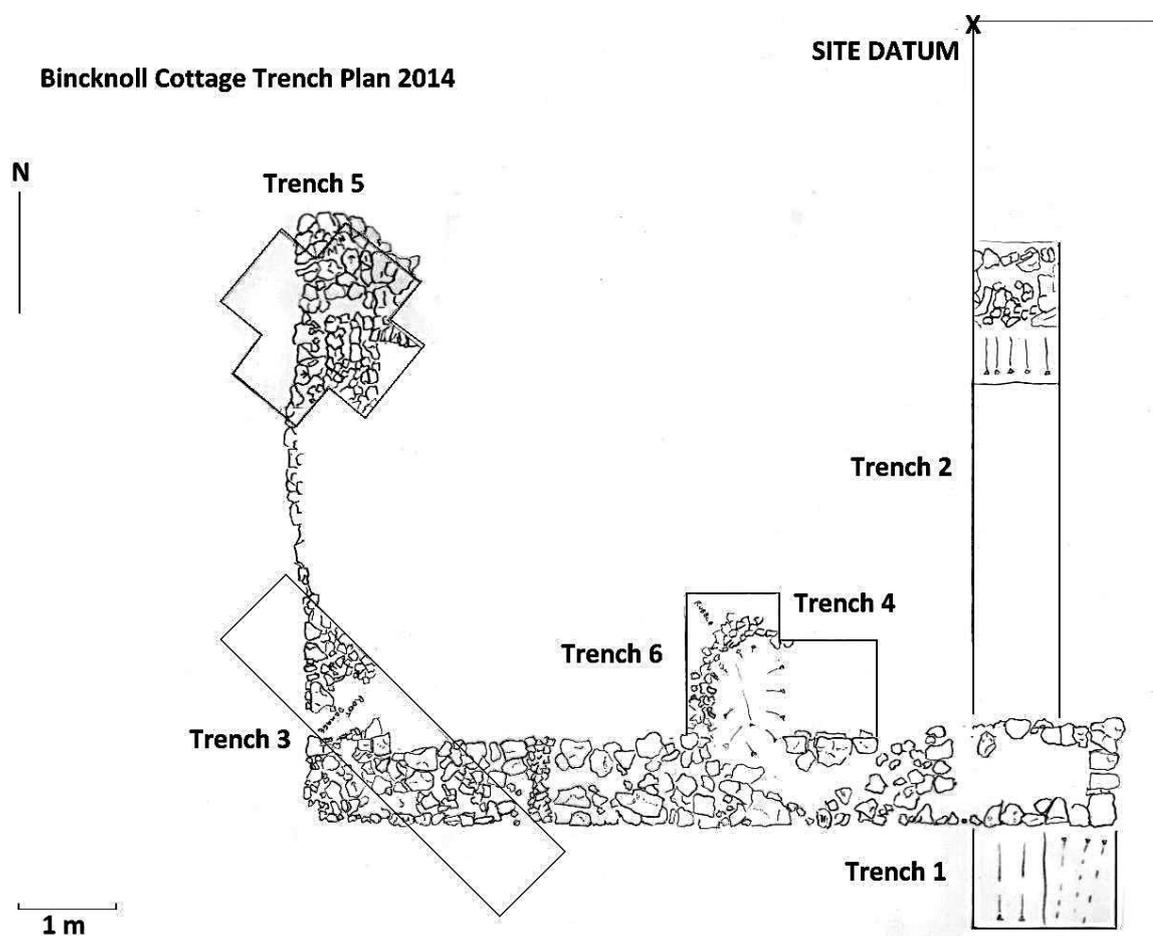
Fig 2 Bincknoll Cottage trench plan 2014 season.

A project design was developed with the Wiltshire County Archaeologist and landowner aimed at ascertaining the dimensions of the structure, recovering dating evidence and representative architectural remains. Execution of the design necessitated a minimum of four trenches to be dug across the partially exposed structure, which was subsequently increased to six (Figure 2). All trenches were dug by hand as the features were visible at ground level (Figure 3 & 4).

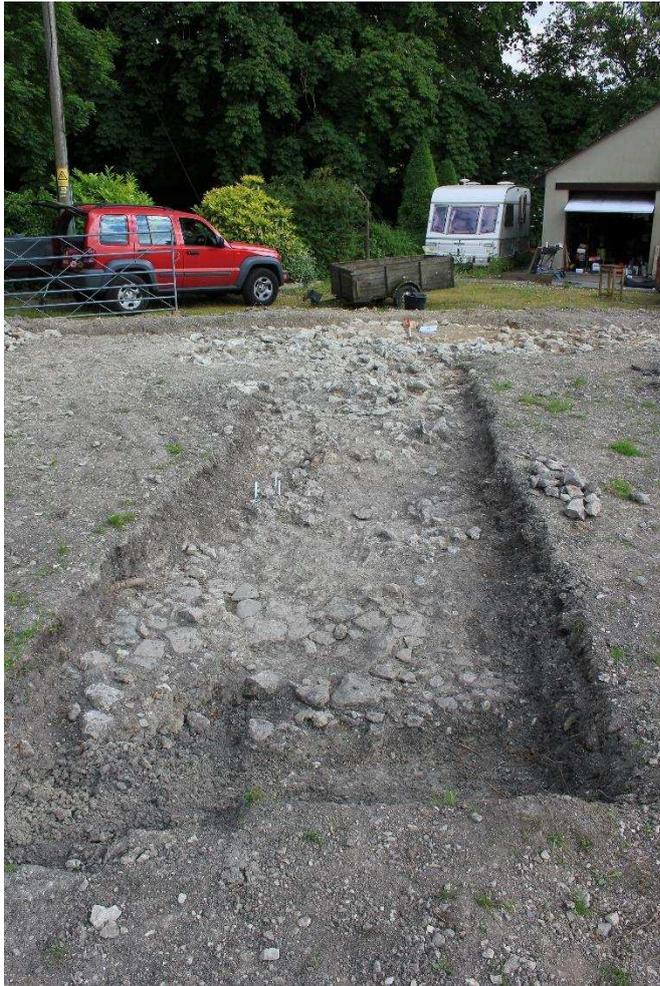
*Fig 3 View, looking south, of the rubble field exposed by the landowner (13/06/2014).*

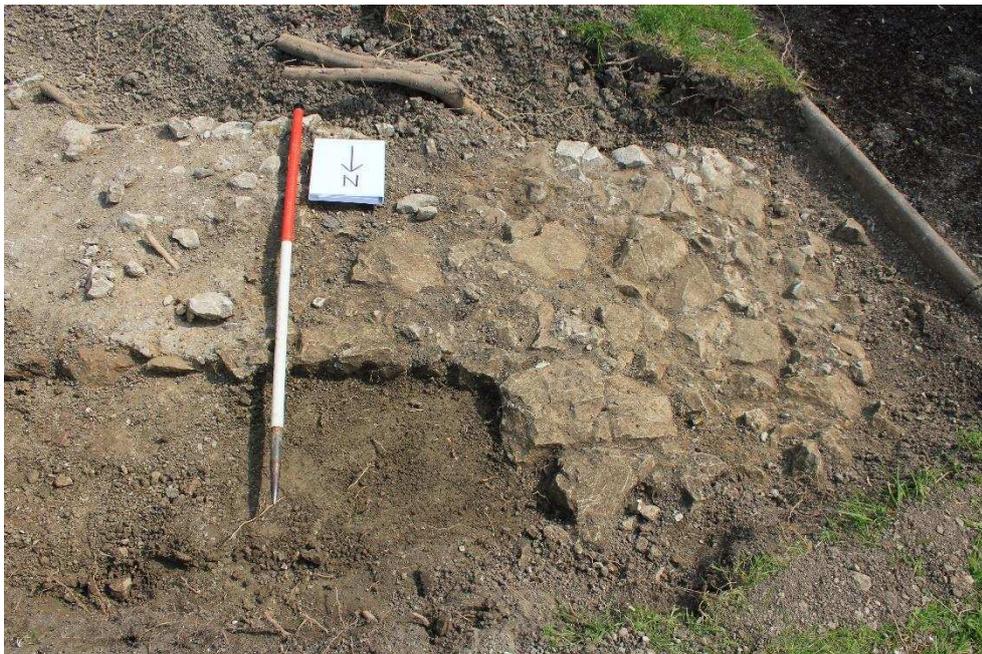
*Fig 4 View of south-western corner of structure, as exposed by the landowner (13/06/2014).*

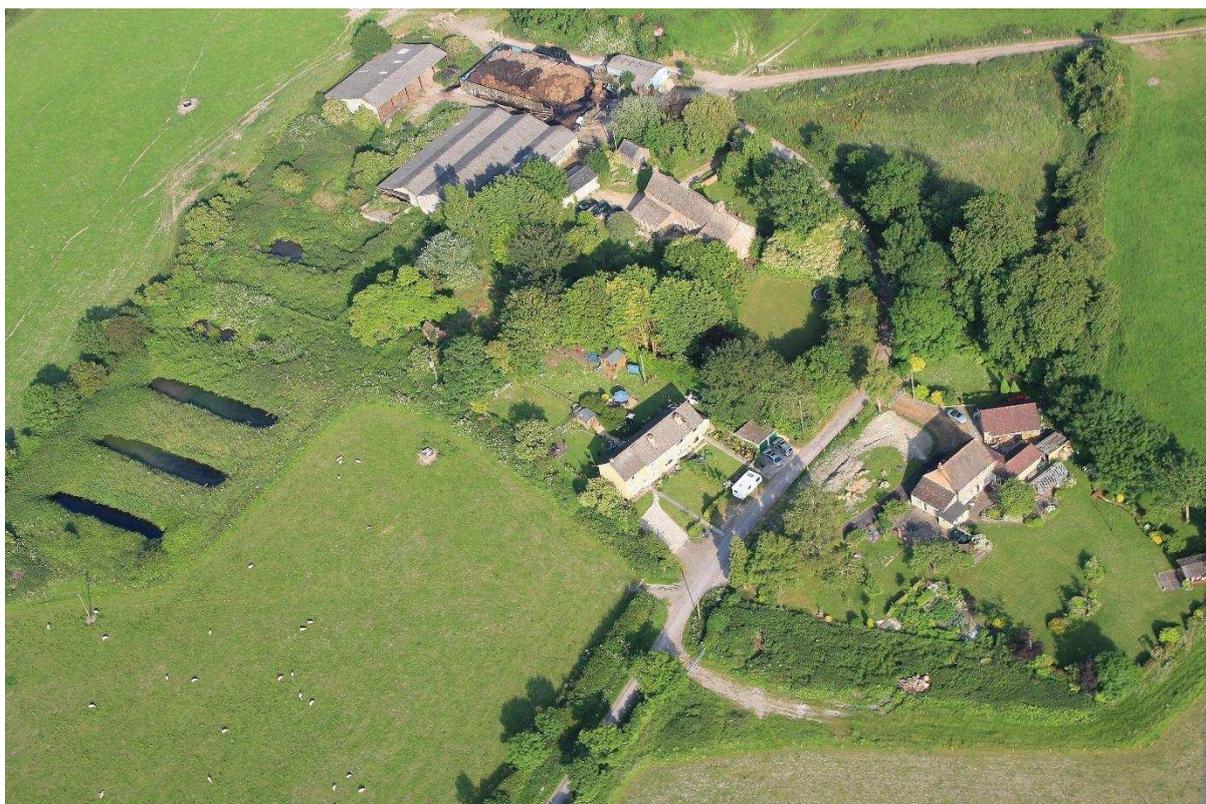
*Fig 5 Bincknoll settlement viewed from the north-west. Bincknoll Cottage stands to the middle right of the picture. Bincknoll Farm Cottages stand in the middle of the picture (modern buildings), top centre is Bincknoll House and Bincknoll Farm (20/06/2014). (Martin Kellett & Bob Clarke)*

The immediate area surrounding Bincknoll Cottage was the subject of an aerial survey. A flight from Kemble Airfield, Gloucestershire made three passes of Bincknoll on 20/06/2014, capturing much of the settlement and the motte and bailey castle to the south of Bincknoll Cottage. No significant features were located. The site was subsequently flown using a Phantom II Vision +, recording the dig in its latter stages.

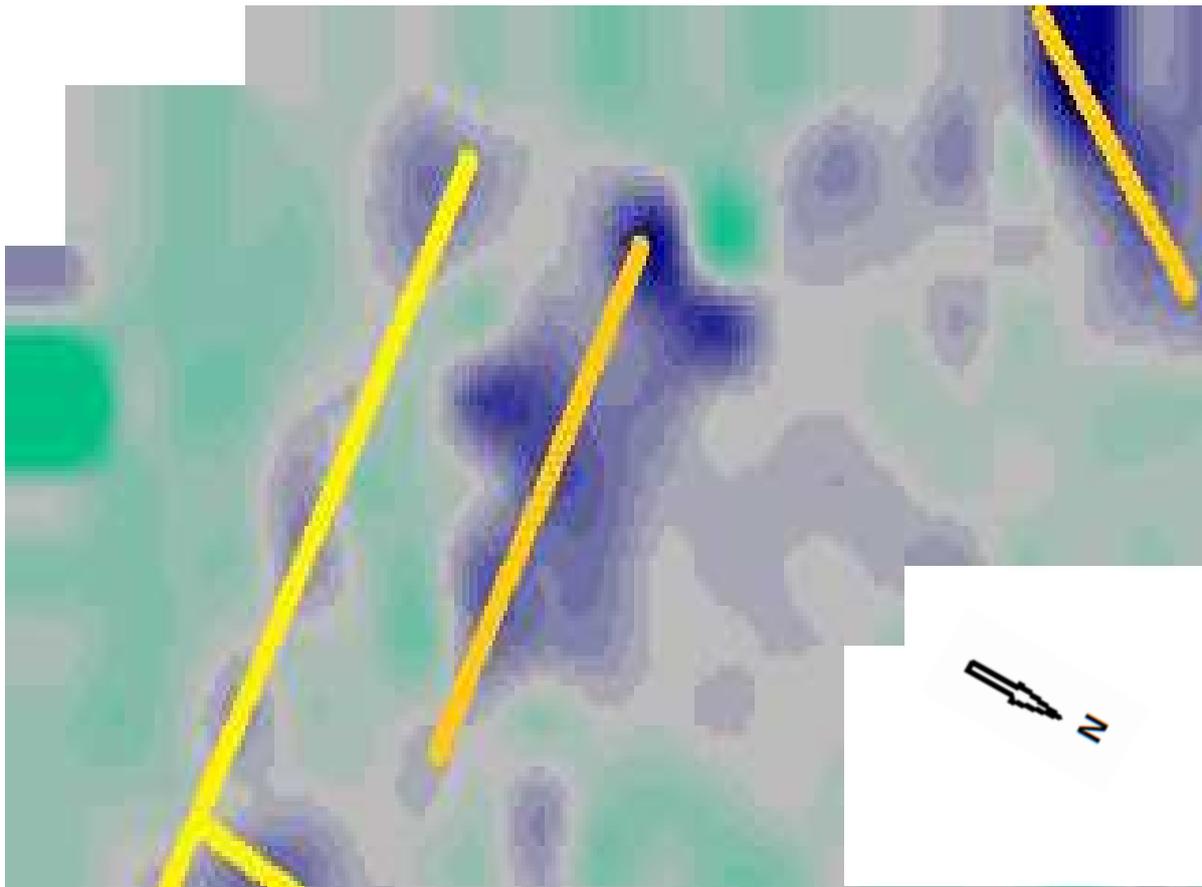
The front and rear gardens of Bincknoll Cottage were the subject of a geophysical survey. The front garden was surveyed on 29/07/2014. The results demonstrated many features across the site (figure 6). The probability of further buried walls was indicated in the results and later proven by excavation. The rear garden, surveyed on 23/09/2014, produced only slight features; those running NW-SE are interpreted as ridge and furrow (figure 7).

*Fig 6 Geophysical results from the front garden. Whilst the plot was difficult to obtain due to the small grid size and material on site it did produce results later confirmed through excavation. Yellow – exposed walls; Orange – suspected walls. (Jim Gunter & Mike McQueen)*

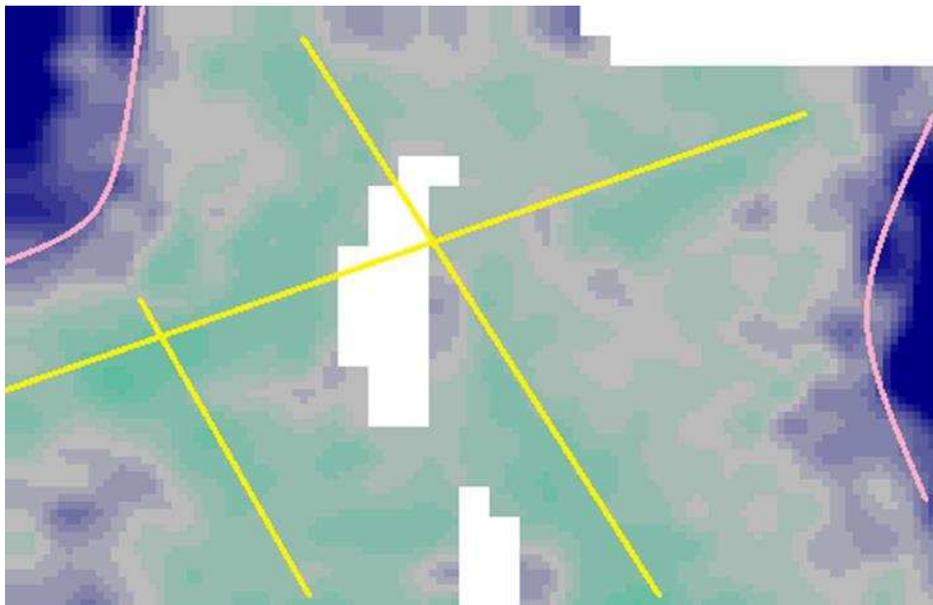
*Fig 7 Geophysical results from the rear garden. The two parallel yellow lines are thought to indicate remnant ridge and furrow. The line running top left to bottom right is probably an earlier boundary or headland. (Jim Gunter & Mike McQueen)*

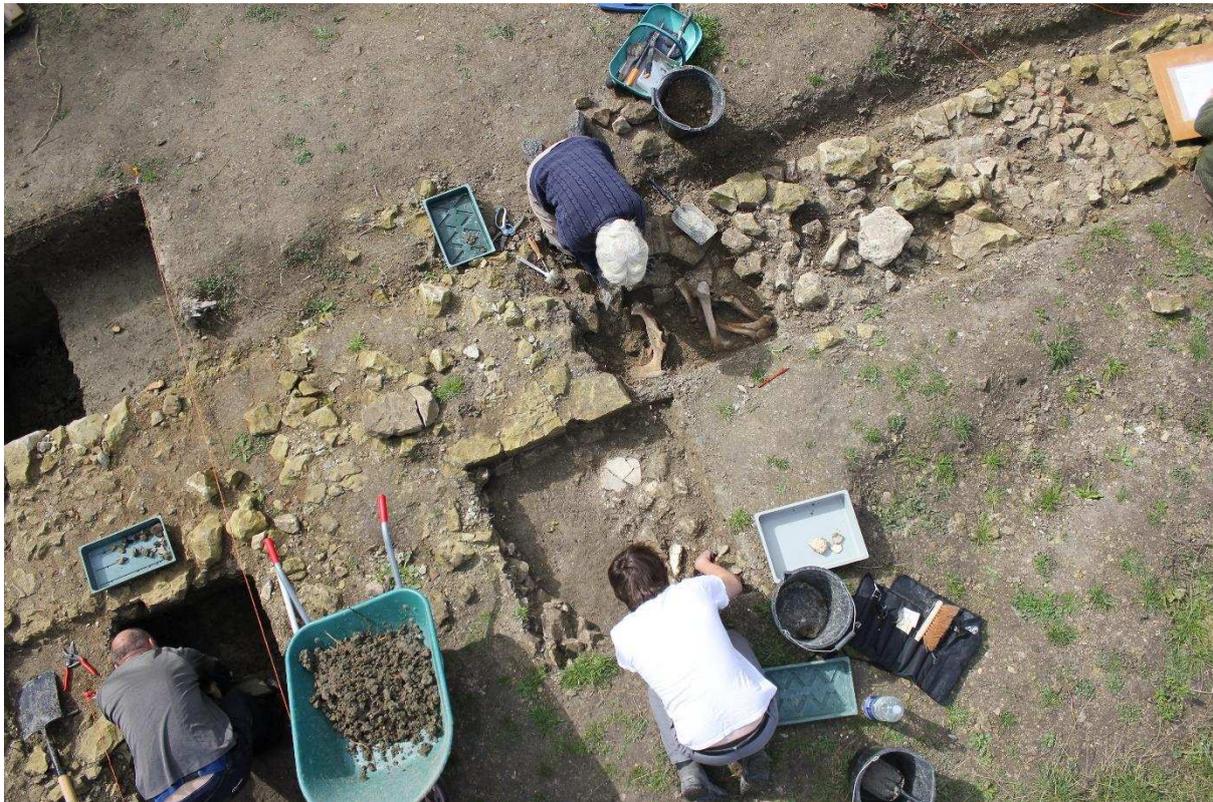
*Fig 8 A general shot of trenches 2, 3 and 6 in work 31/08/2014. (Image Rob Lowe & Rob Lowe)*

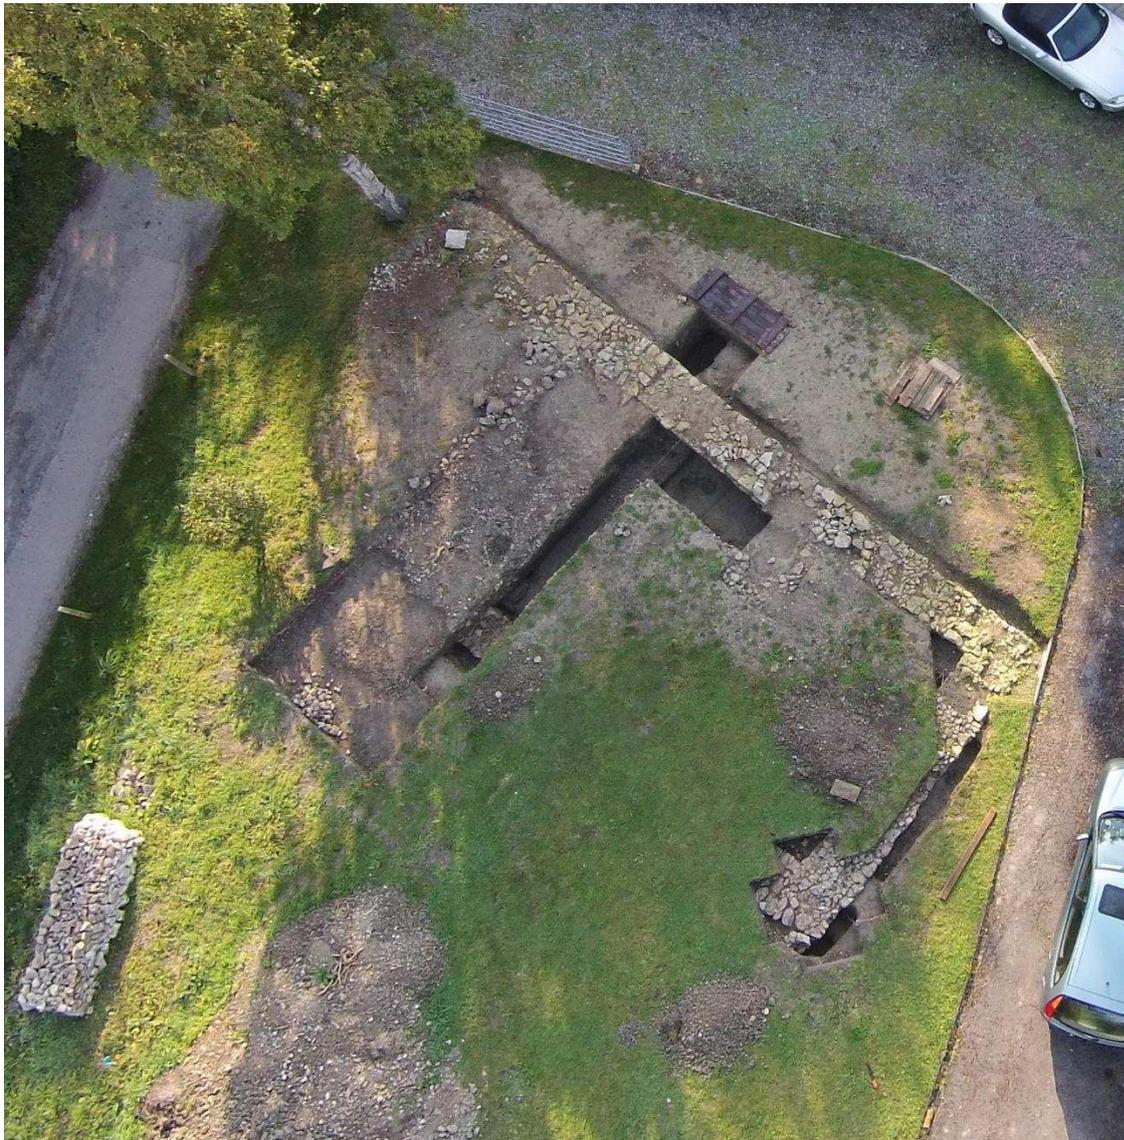
The excavation revealed three sides of a structure constructed mainly of chalk blocks and rubble. The building is aligned perfectly east-west. The western end is the focus of this report. The eastern end is to be investigated through excavation in 2015. The work revealed a structure 6103mm wide (internally 4303mm), comprising walls with a uniform width of c.900mm across the first secure course (Figure 9). All structural components were generally well preserved, although the uppermost courses have begun to decay due to prolonged exposure to the elements.

*Fig 9 General layout of site at the end of the 2014 season. Image taken from a Phantom II Vision + (Mike McQueen)*

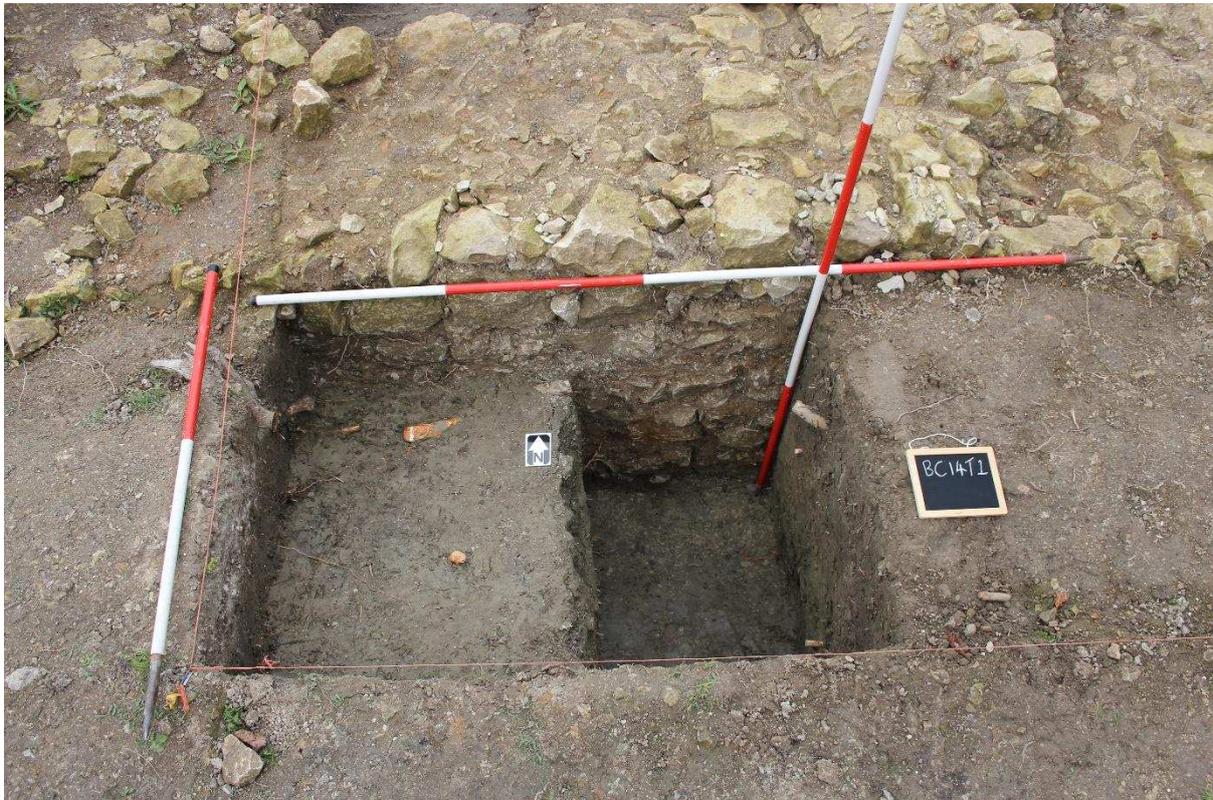
Trench One (T1) was located against the external face of the southern wall. It revealed 1170mm of structural remains that became increasingly poor quality as the depth of the excavation increased (Figure 10). Below the topsoil just one context (012) was recognised. Context (012) comprised a mid-brown solid clay that had a clear horizon with the natural (039). Context (012) contained a single animal tooth, substantial amount of worked flint along with small amounts of charcoal (> 3mm in size throughout the matrix). The natural (039) consisted of chalk-based marl. No foundation trench was noted in T1.

*Fig 10 Trench one showing the depth of the southern wall and general rubble appearance.*

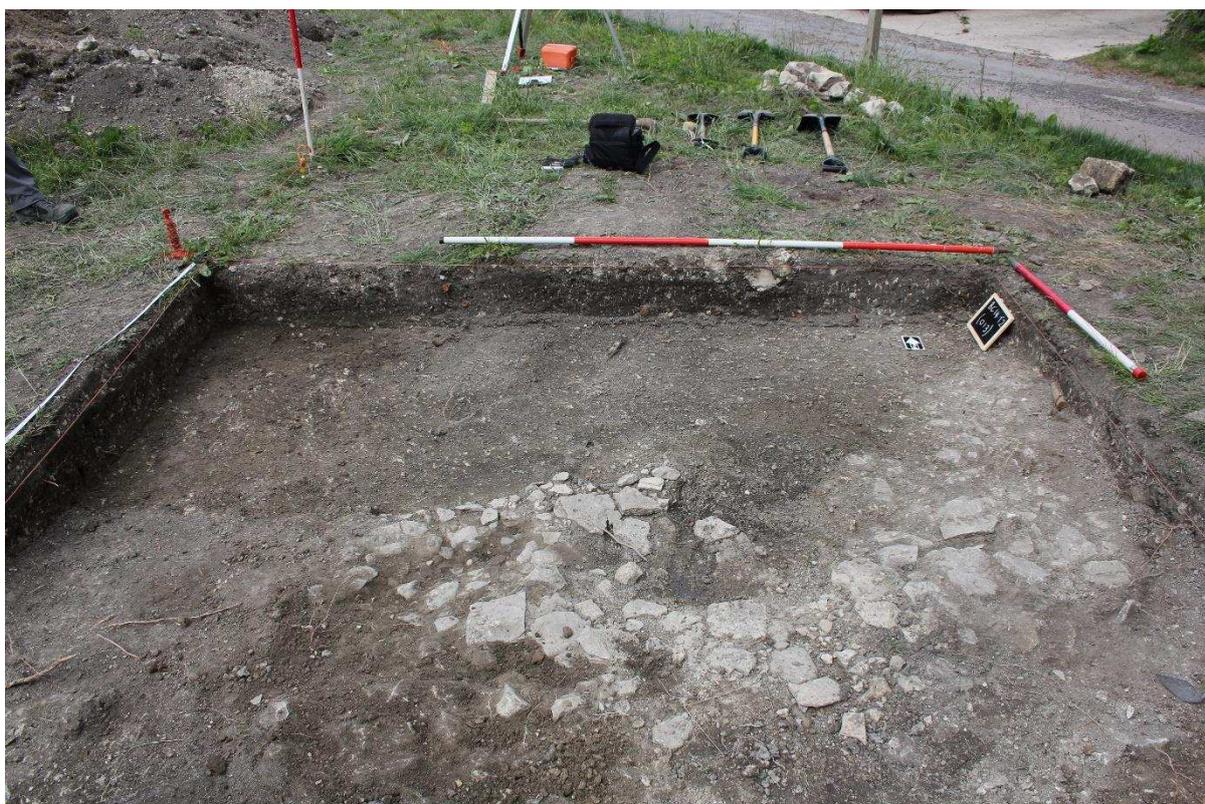
*Fig 11 Trench two showing the northern end of the investigation. Here the rubble field steadily petered out, suggesting the northern wall had collapsed outward. This was before the robbing activity located later by the excavation.*

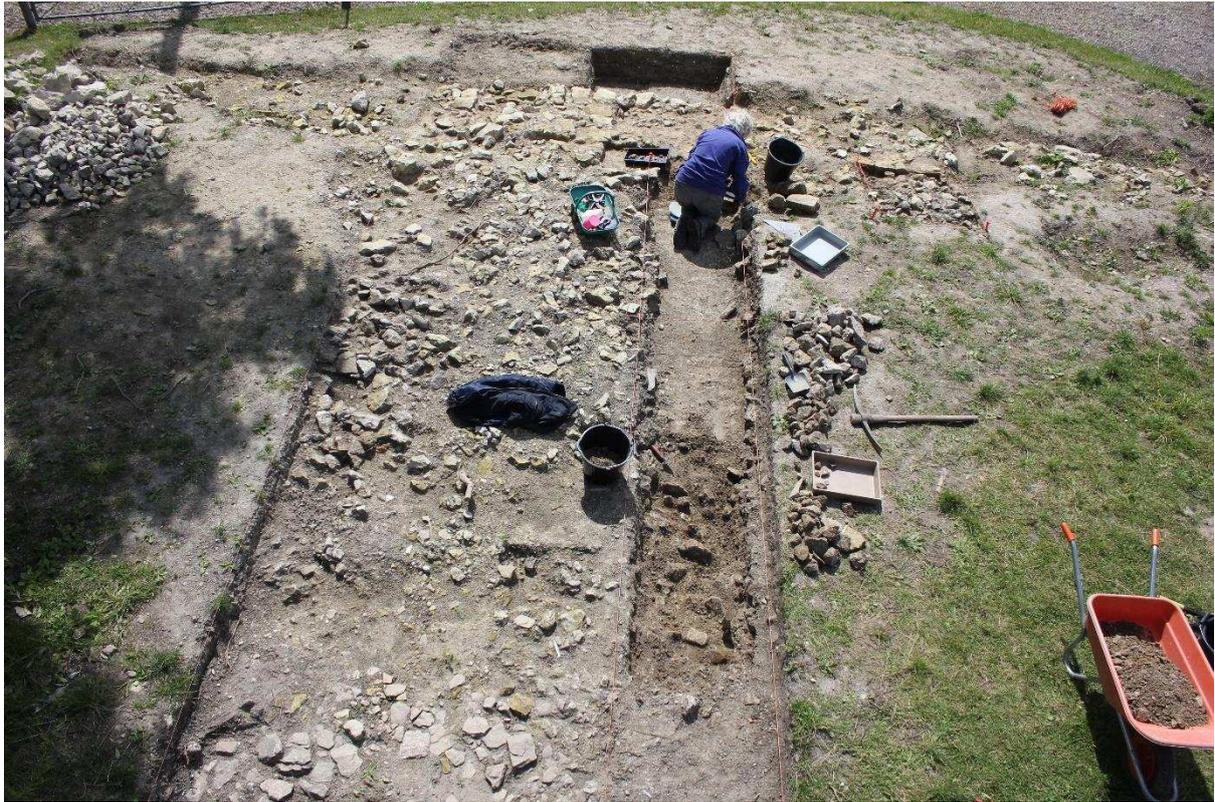
*Fig 12 Trench two looking south. The rubble field across the site was extensive. An exploratory trench through the spread can be seen in the process of excavation.*

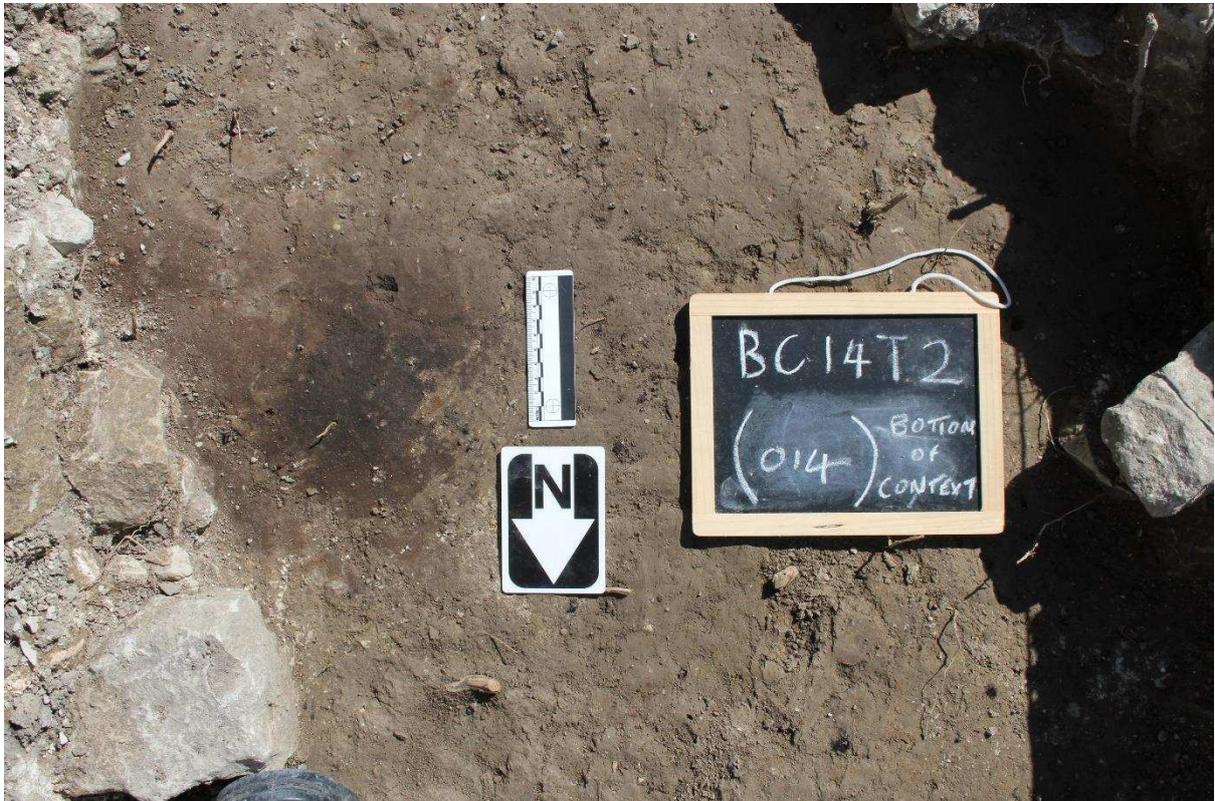
*Fig 13 Burning patch. This feature formed part of the demolition process.*

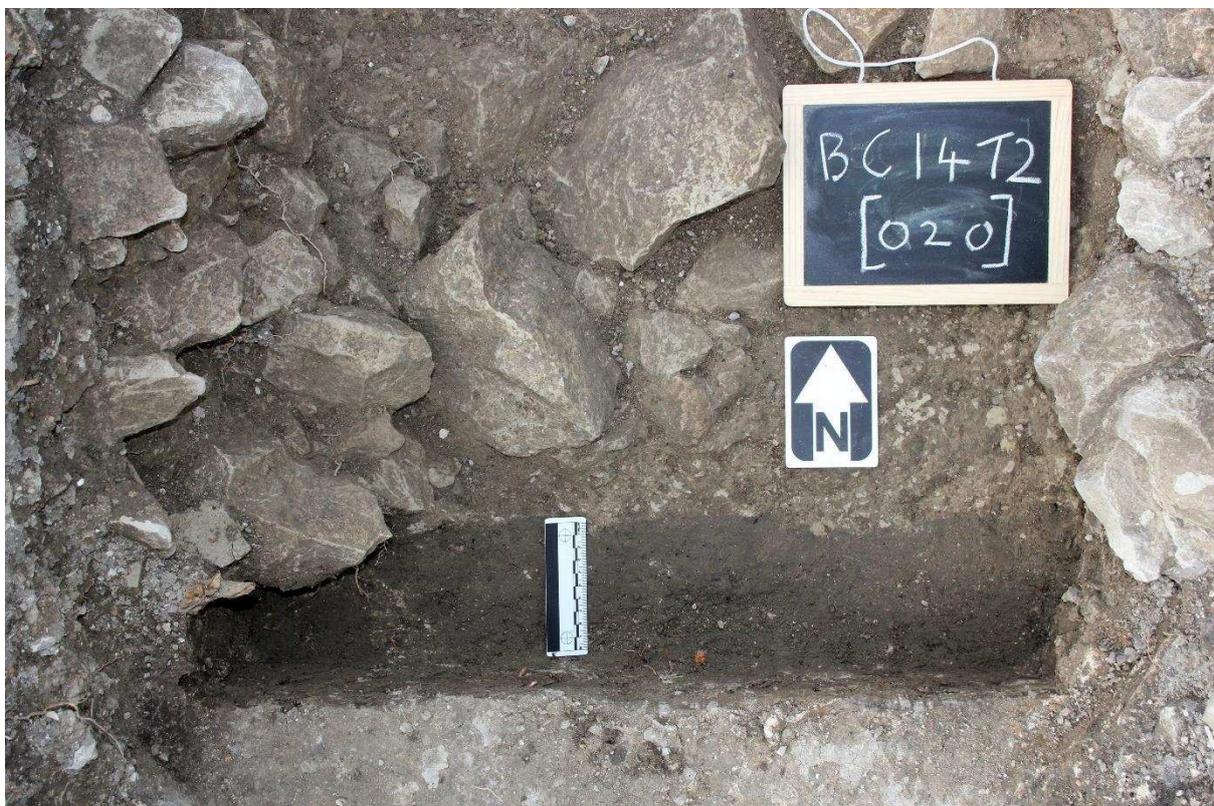
The northern wall of the structure was located in T2, where it was found to be heavily robbed out. During the demolition phase, a trench [020] had been dug alongside the wall inside the building (Figure 14). At least 600mm of the wall appears to have been removed, and a mix of mortar and smaller pieces of building material (< 60mm on average) thrown back into the robbing trench afterwards. Evidence for this activity must have been visible for some time afterwards, as a slight soil line (< 5mm in depth) had built up in the cut of the robber trench. The trench was later filled with mixed rubble material that spread across the site as the southern wall collapsed. Beyond the northern wall, context (013) was very clean with only a few struck flints and small pieces of roof tile noted. It did, however, display the robber trench cut [020] clearly, as there was a large amount of discarded mortar that had been cast on top of the surviving north wall.

*Fig 14 Trench two, showing the edge of the robber trench [020] and the remnants of the north wall.*

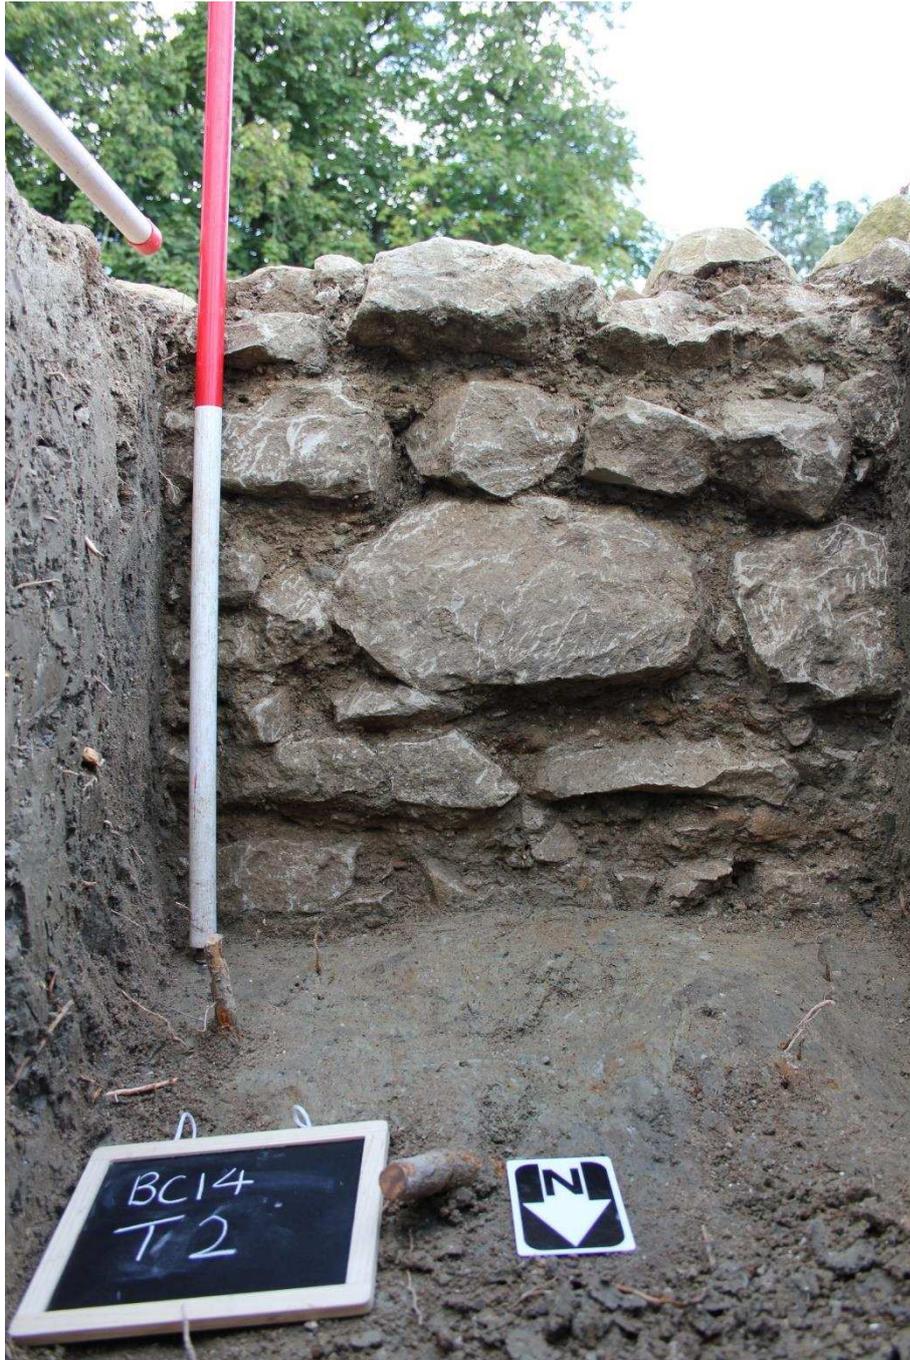
The internal face of the southern wall was also investigated (Figure 15). The rubble context (014) in this area produced a large amount of badly decayed, white painted plaster, a few examples displaying a red painted lines c.5mm in width. There was also slight evidence of other colours being employed. Again, a number of flint flakes indicative of knapping waste were located directly below the rubble field in context (040). No evidence of flooring, either earth, mortar, or tiled, was located.

*Fig 15 Trench two detail of inner face of southern wall.*

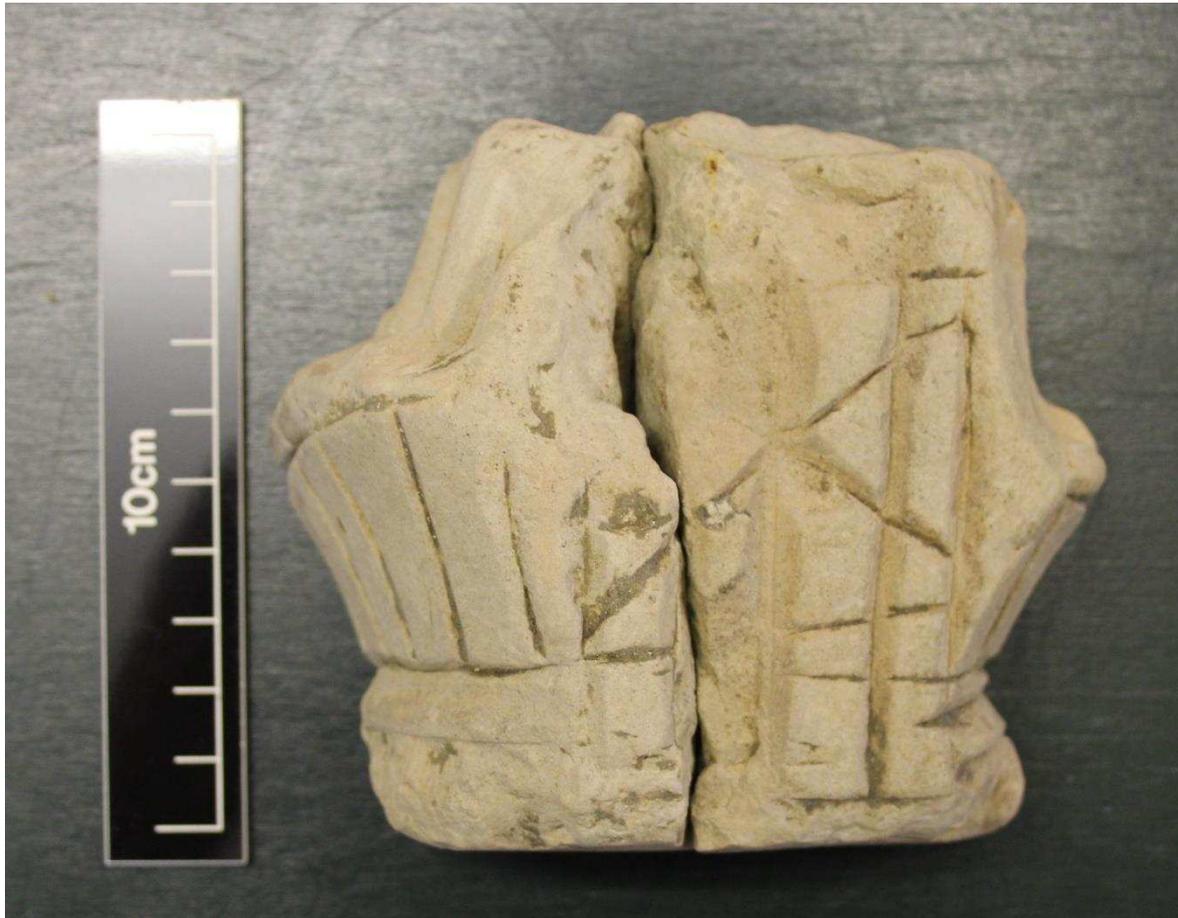
Context (040) did produce two diagnostic pieces of carved chalk, which fit together to form one near complete item (Figure 16). This has been provisionally dated to the late fourteenth century and may have formed part of a monumental structure (Prof. Warwick Rodwell pers. comm.).

*Fig 16 Carved chalk object recovered from trench two.*

Pottery of eleventh and twelfth century date onwards, recovered from across the site, also supports a tentative link with the documented chapel. However, in all cases the context for this pottery was in the demolition layer, frustrating the chance to secure construction dates or phases. The paintwork is possibly of pre-Reformation date, although, without technical analysis of a sample, the suggestion has to be speculative (Dr Ellie Pridgeon pers. comm.). The carved chalk object appears to have a very 'rustic' execution, again making a secure date difficult.

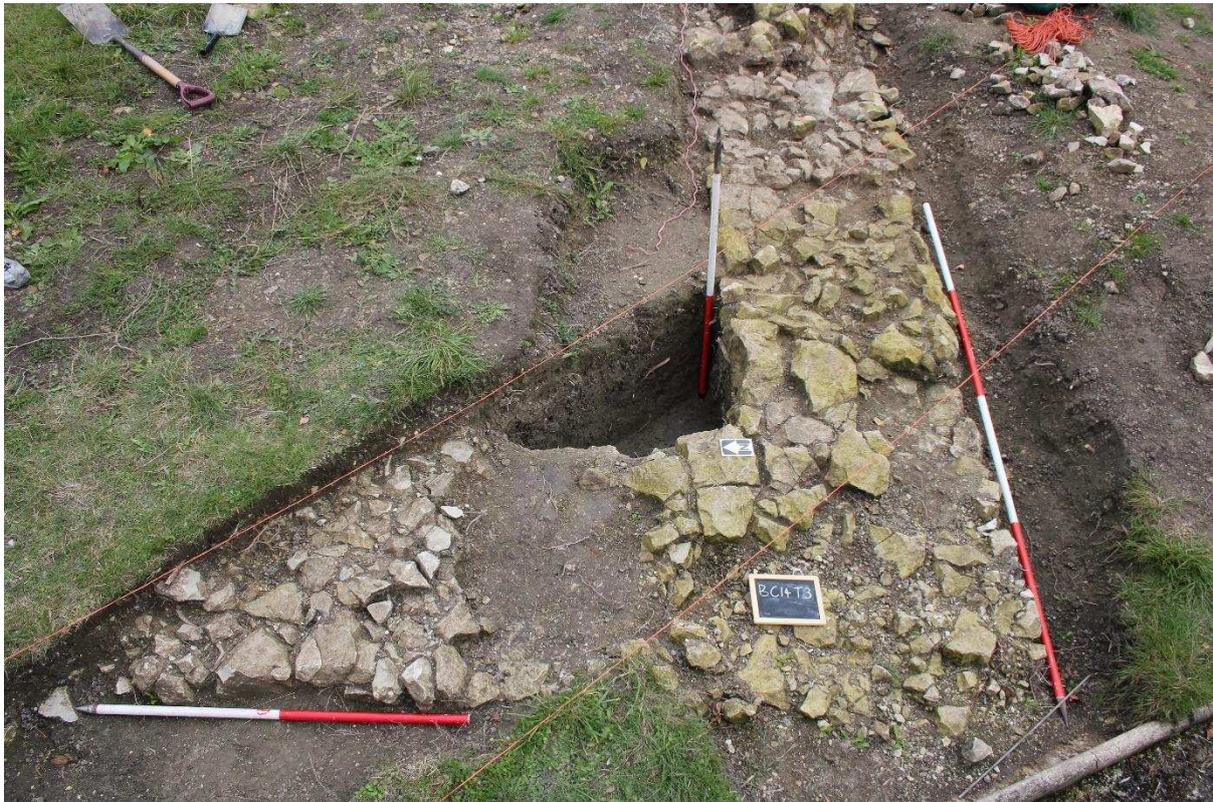
Trench Three (T3) was placed across a section of wall on the western extremity of the known south wall, intending to locate any extant evidence of a corner to the structure. This trench revealed a wall with a right-angled return (Figure 17). The internal context (025), comprising a dark brown soft soil, was investigated. Substantial tree roots running through this area appear to have modified the context. No securely datable finds from context (025) were retrieved, although structural information noted that the change in poorer quality stone recognised in T1 occurred at the same depth as here.

*Fig 17 Trench three clearly showing the south west corner of the building. The section of missing wall is the result of tree root damage.*

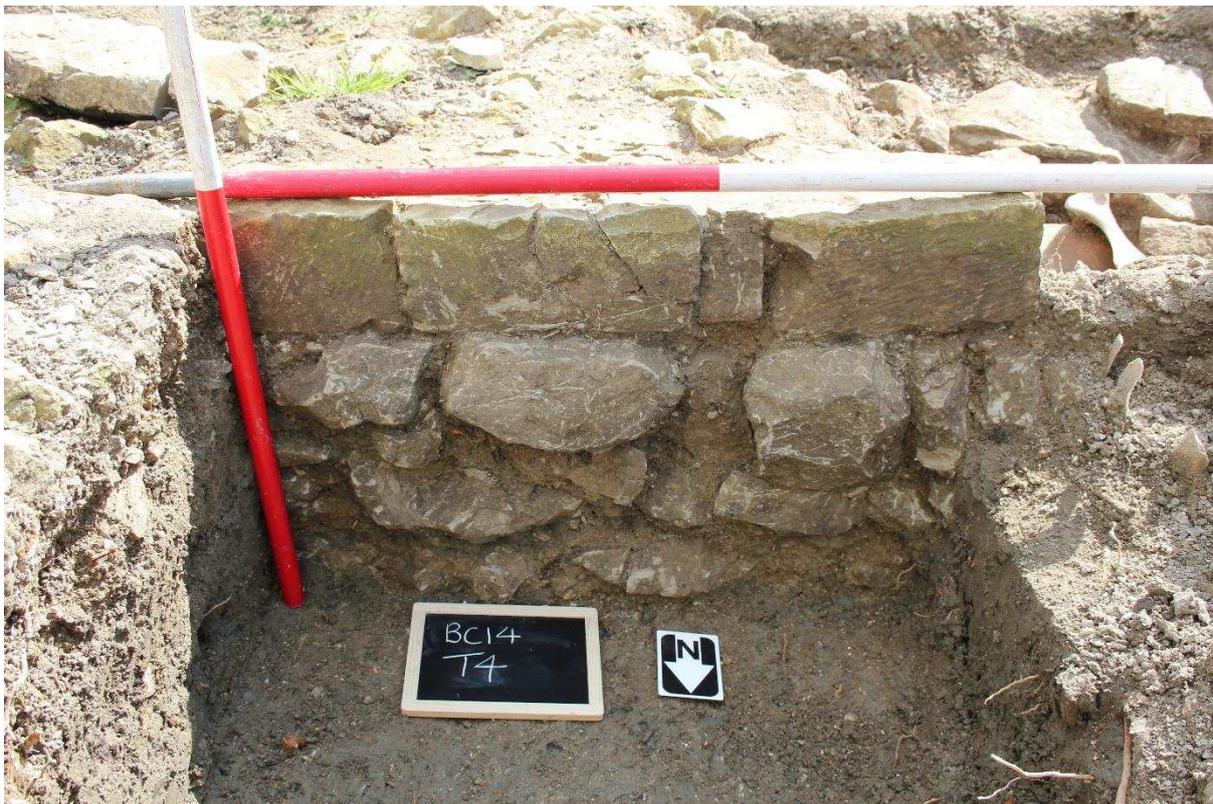
Trench Four (T4) investigated the internal face of the southern wall where three dressed stones were found in the uppermost course. At just 1m by 1m T4 was very productive. The demolition layer comprised sheets of white painted wall plaster, roof tiles and architectural features – wedge shaped chalk blocks interpreted as a voussoir. Pottery sherds were present – predominately from the Ashton Keynes production site – although one sherd, probably originating in the Bristol area (Barton 1963), was located in the upper fill of the context (017). Below the rubble layer, the edge of a pit was discovered containing articulated animal bone. This is further described in the narrative of Trench Six. The three dressed stones, fashioned from chalk blocks, visible in the internal uppermost course of the wall, were not repeated further down (Figure 18). The next course, comprising unshaped stone, projected 70mm into the building's interior. Beyond that the composition followed that recognised in other areas.

*Fig 18 Inner face of the southern wall in trench four. Note finely dressed top course and the protruding second course.*

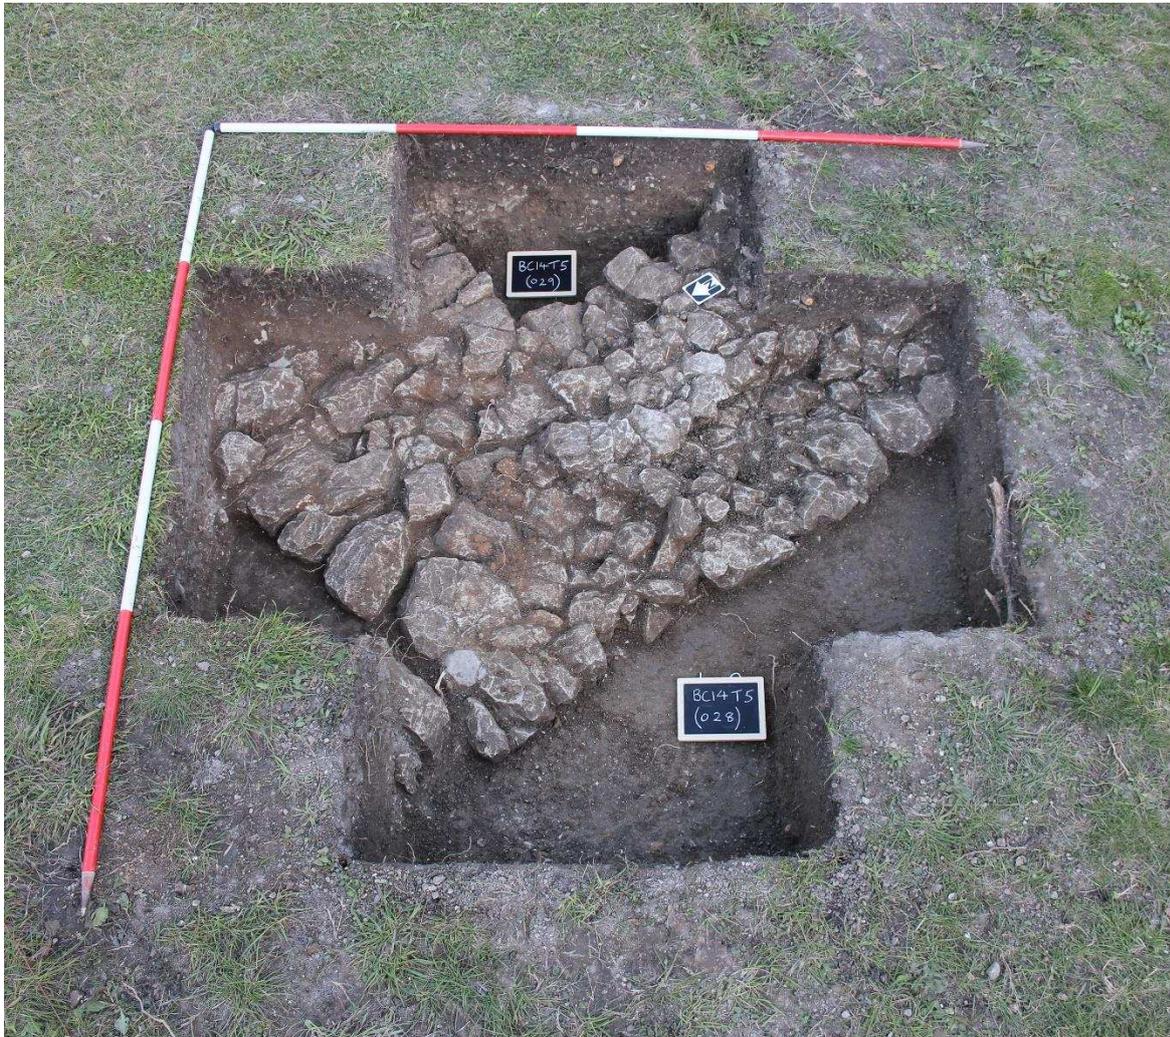
Using the positional information from T2 and T3, Trench Five (T5) was placed to locate the northwest corner of the structure. As with other areas of the site, the wall was located after removal of the turf (150mm) (Figure 19). The wall at this location mirrored the construction techniques recognised in other areas, with one exception: it has an extension protruding north for a further 450mm at a lower level. The extant wall was bonded with substantial amounts of orange/red mortar. Both sides of the wall were investigated. Inside the structure, context (029) comprised a yellow/brown clayey deposit that was friable in texture, from which two small pieces of white painted plaster and one, post-17th century pot sherd, were recovered. Outside the structure, context (028) comprised a mid-brown soil, firm in its compaction, and with a small percentage of pebbles. Two fragments of glass and one piece of secondary worked flint were recovered.

*Fig 19 Trench five showing the north west corner of the building. Note depth below topsoil.*

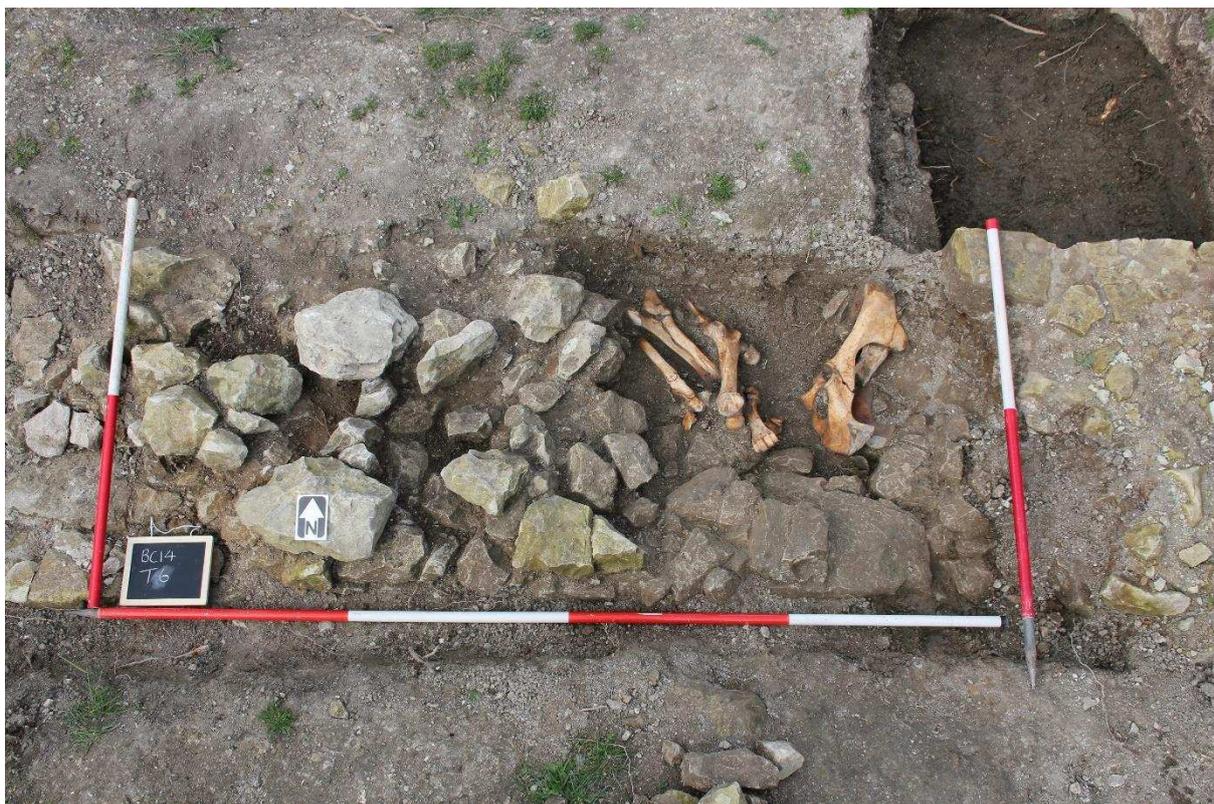
*Fig 20 Trench six southern section. The pelvis and rear legs of the animal burial. Note jumbled stones to west of bones. These are remnants of the wall that were dislodged when the burial pit was first dug.*

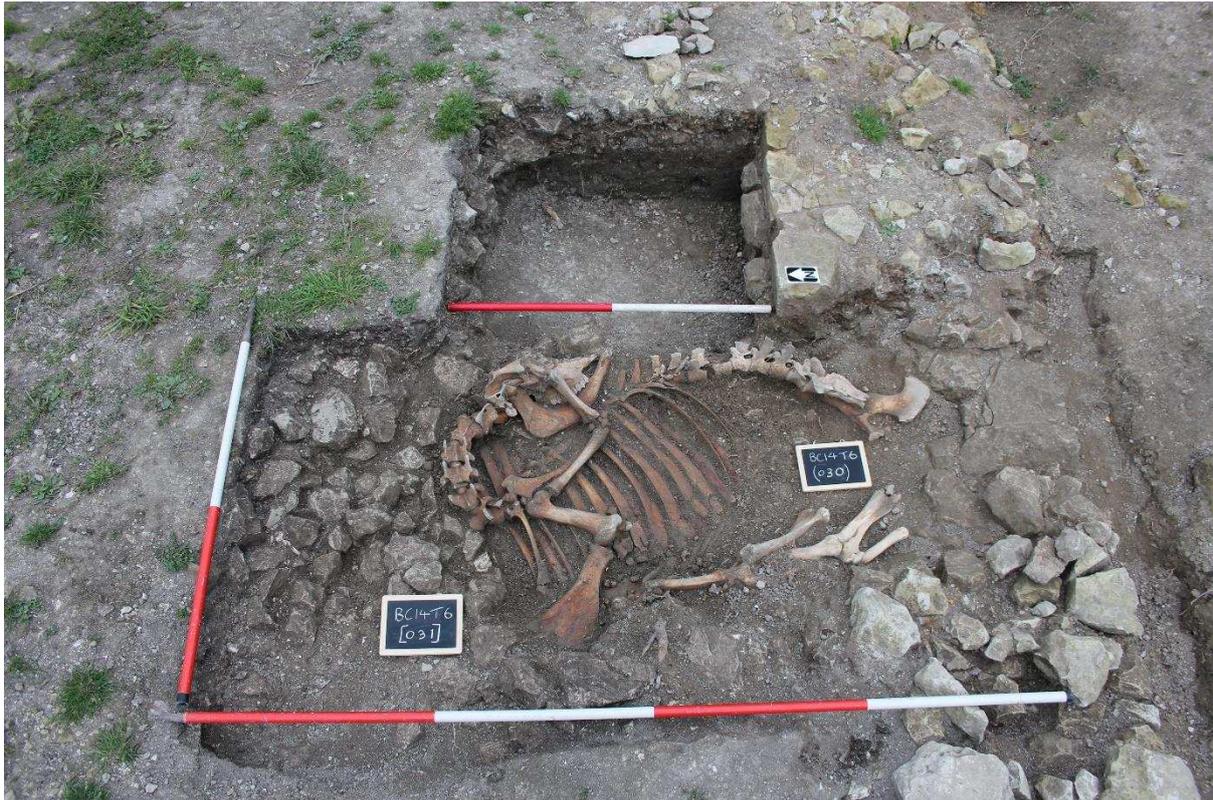
Trench Six was opened to investigate the animal burial noted in T4. The burial was contained in an oval pit [031] that partially cut through the southern wall and the demolition rubble layer. The animal, identified as a cow, was laid on its right side and aligned north-south with the head at the northern end. The burial pit had a slight concaved base that extended below the rubble layer. The pit truncated the wall at its southern extremity; a number of large stones laying on top of the wall 700mm to the west are the result of this truncation (Figure 20). The articulated animal remains were complete; however, it appears to have required some effort to place the animal in the pit. The head had been bent back onto body and the left foreleg twisted up over the body and head. The right foreleg was bent back parallel with the lower body and both rear legs had been crouched (Figure 21). Examination of the burial has yet to determine whether the animal had been destroyed or died due to unnatural causes.

*Fig 21 Trench six cow burial. Note how the pit truncates both the wall and rubble field. The animal has been laid in the pit in an awkward position. The head has been thrown back over the body and the left foreleg is twisted up over the carcass.*

The chapel was described in a bond from 1609 as 'All that decayed Chapell –' (WRO 326/3–2). By the time the cow discovered in trench six was buried around a century later, it would appear that any above-ground remains of the structure had been removed. The pit dug to bury the animal was not only cut through the rubble layer, the rear quarter of the animal was also laid over the southern wall. Moreover, large stones from the wall had been removed and were now resting on top of the wall immediately to the west of the pit as if thrown there during the excavation of the pit. It is highly possible that the area once containing the building was, for a period afterward, considered waste ground, probably difficult to work due to the amount of rubble just under the turf line. The disposal of the cow on waste ground should not then come as a surprise. The discovery of a clay pipe bearing a local early eighteenth-century manufacturer's name, along with sherds of post-medieval pottery, helps to reconcile the archaeological and documentary evidence.
