The Lost Chapel of Bincknoll, Broad Town,  
North Wiltshire:

An interim report covering the excavations at  
Bincknoll Cottage 2014

Site Report 2014:1

March 2015

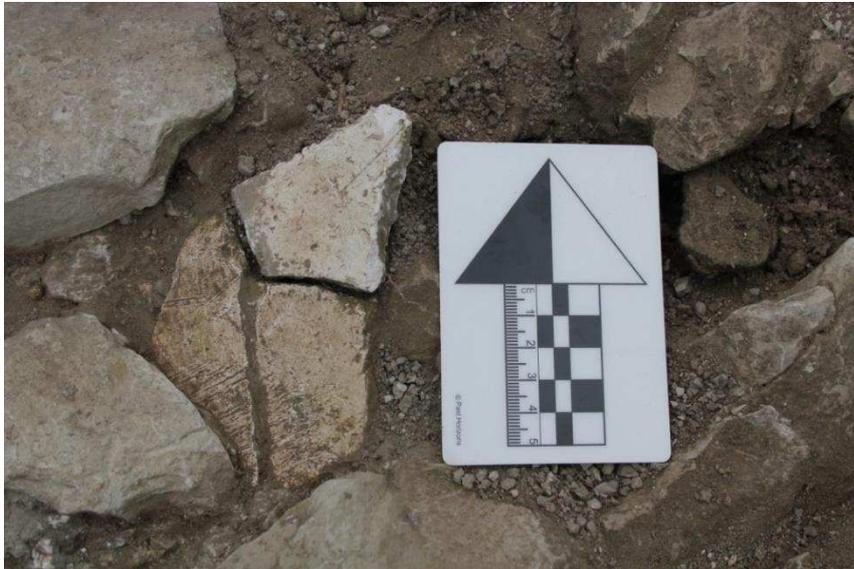
*Fig 22 Trench four. Plain, whitewashed plaster was evident across the southern side of the site. In trench four substantial pieces were encountered.*

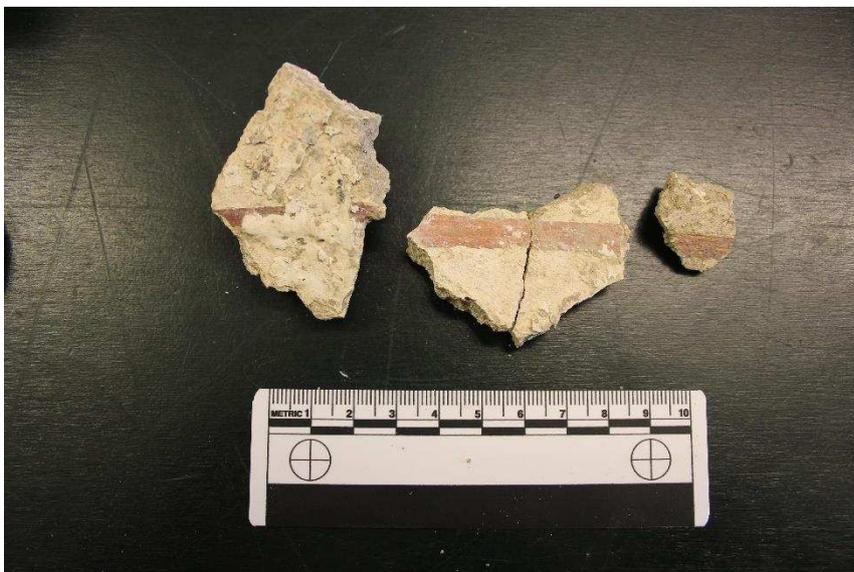
*Fig 23 Discovered during the initial southern wall clean up. Examples of whitewashed plaster with red lines painted across them. Suspected colours on other small pieces include green and black.*

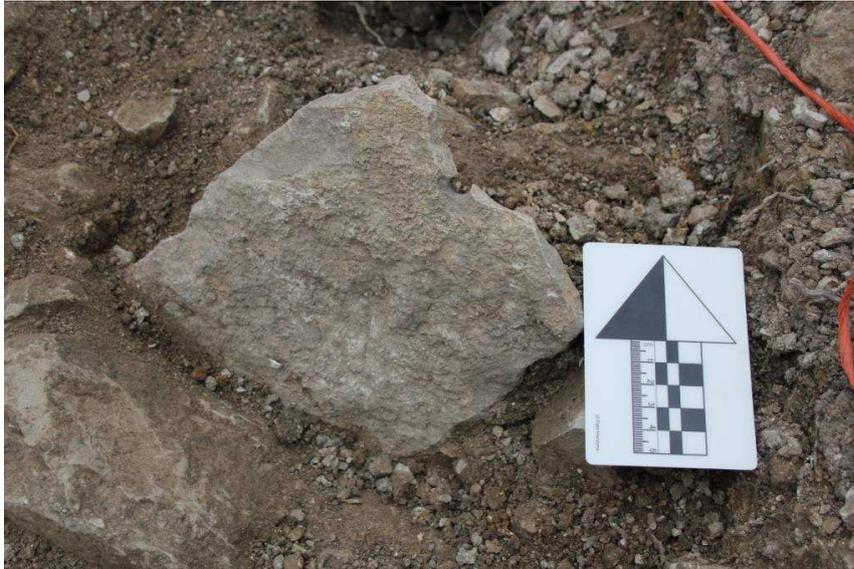
*Fig 24 Trench four near complete roof tile. A number of roof tile fragments were recovered from the rubble field and trench four. This suggests the final phase of the structure was tiled rather than thatched.*

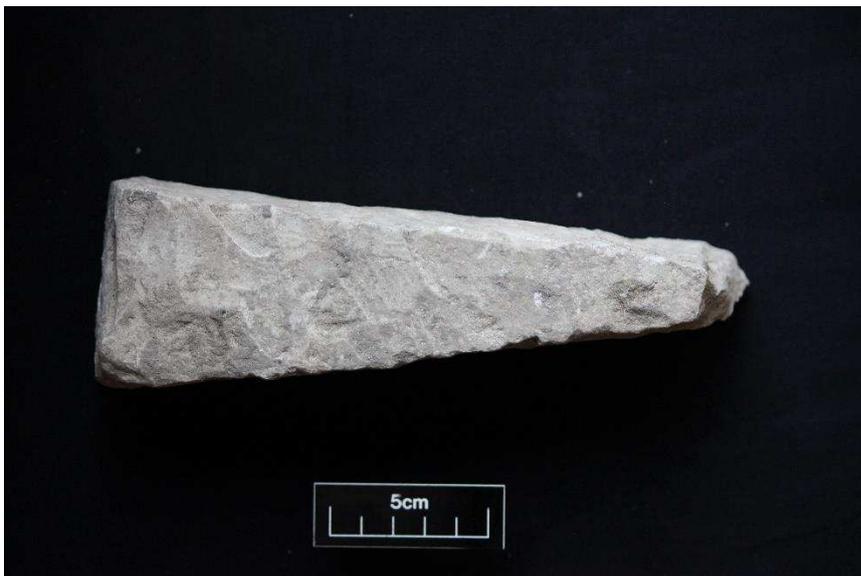
*Fig 24 Trench four voussoir. This example was one of ten located during the investigation of the southern wall. These wedge-shaped blocks are thought to form part of an arch structure, possibly over a window or doorway.*
