WILTSHIRE ARCHAEOLOGY FIELD GROUP

YATESBURY AIRFIELD DEFENCE SITE, CHERHILL, WILTSHIRE.

Report Number 2014.01

Event:	Building Recording and earthwork survey of Cherhill Down Barrow and Gun Emplacement
Event type:	Survey
External Reference:	WAFG 2014.01
Dates:	26.01.2013 and 18.05.2013
<i>Project Details:</i>	
Event/Activity Types – Building Recording and Earthwork survey	
Thesaurus Event Types	
BUILDING SURVEY	
PHOTOGRAPHIC SURVEY	
ANALYTICAL EARTHWORK SURVEY	
AERIAL PHOTOGRAPH INTERPRETATION	
Event/Activity References - None recorded	
Organisation:	Wiltshire Archaeology Field Group (WAHNS)
Associated Individuals	Brian Clarke, Stella Maddock, Dan Miles and Amanda Dickson
Associated Organisations -	
<i>Location</i>	
Grid Reference	
Centred NGR 406740 169630	
Administrative Areas	
Civil Parish	Cherhill, Wiltshire
Address - None recorded	
<i>Description and Sources</i>

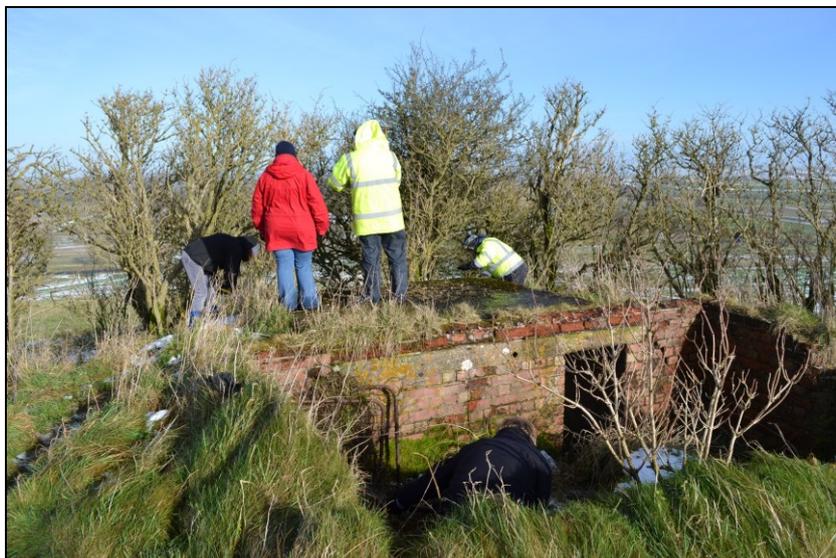
Fig. 3 Recording the site.

The structure was recorded using a running dimension method. A tape was run horizontally along each wall in turn, and cumulative measurements noted for the start and end of each feature along that wall. The diagonal across the structure was noted to check accuracy. Vertical measurements were taken across all features to enable elevations to be drawn. The direction of each section of the zigzag entrance passage was determined using a prismatic sighting compass and its length measured. A plan and section were drawn at a scale of 1:50 and elevations at 1:20 (Appendix 3, Figs. 1-4).

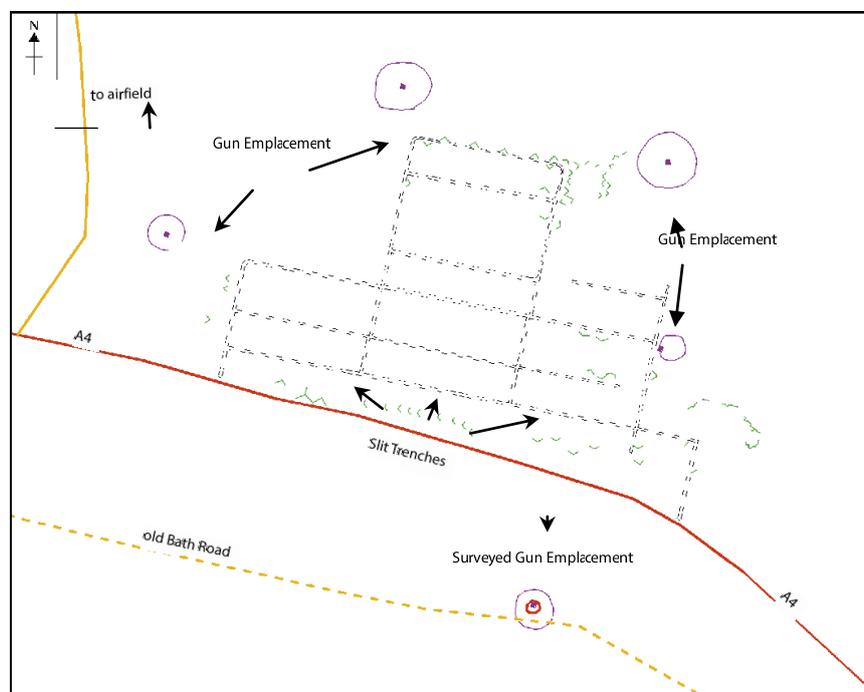
Fig. 4 Aerial photograph mapping indicating the gun emplacements in relation to the Radio School camp (for clarity, only roads are depicted). This map is not to scale.

8.1.1 The gun emplacement is identified in the earliest available aerial photograph, dating to 1941 (11/02/1941, RAF/HLA/395). The gun emplacement is visible as a solid structure in the centre of the Bronze Age barrow and surrounded by a ring of barbed wire. It is also visible on later aerial photographs, dating to 1942 and 1946. Similar features were identified encircling the Radio School which is located on the north side of the A4 road. There appear to be four more of these features, visible as rectangular structures divided into two compartments and surrounded by a ring of barbed wire. These are located at SU 06406 70748, SU 06983 70658, SU 06993 70126 and SU 05953 70319. The most northerly of these (SU 06406 70748) is the one described by Gordon Chivers as being a gun emplacement.

Other defensive features have also been identified at RAF Yatesbury. A number of pillboxes, some of which also supported light anti-aircraft gun emplacements, defended the northern flying field. A large number of small v-shaped slit trenches have been identified surrounding the Radio and Radar Schools. It is thought that these would have had a defensive role in protecting the airfield rather than for ground crew protection from air raids despite the seemingly irregular pattern of some of the trenches (see Fig. 4).

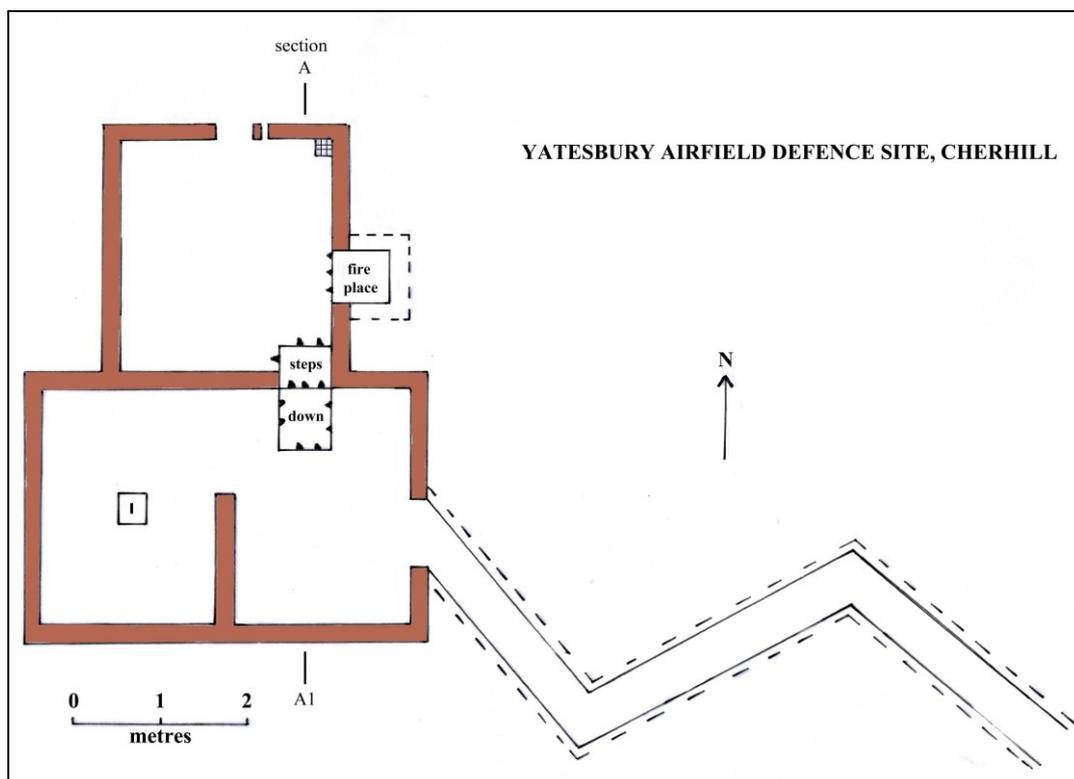
Fig. 5 Plan of light anti aircraft gun emplacement

The Second World War gun emplacement was built into the southern half of the Bronze Age barrow, destroying most of the central area. It consists of three different parts; an unroofed brick rectangular gun pit (twin); a brick and concrete roofed blast shelter, and a concrete lined zig-zag blast entrance way, that opens up on the eastern side of the barrow.

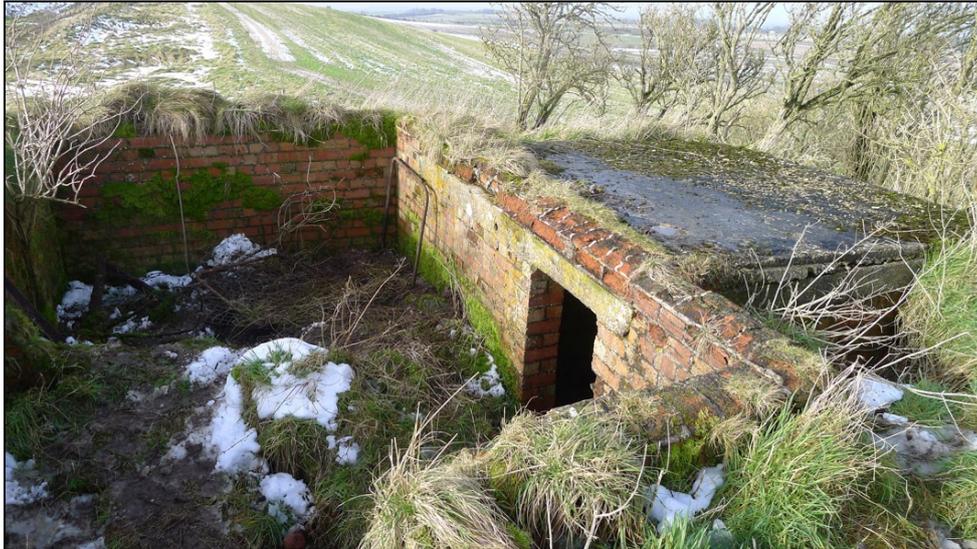
Fig. 6 Gun pit with rear blast shelter

The gun pit is an unroofed rectangular brick structure divided into two chambers by a central wall (Fig. 6). The chambers are interconnected by an entrance way in the northern

part adjoining the blast shelter. The floor is of concrete and the walls are brick in English bond with alternate courses laid with headers and stretchers facing. The bricks measure 22 x 10.5 x 7 cm.

The open gun pit is in poorer condition. The top course of brick has eroded away, the brick dividing wall has collapsed at its northern end and the gun pit is overgrown and full of rubbish.

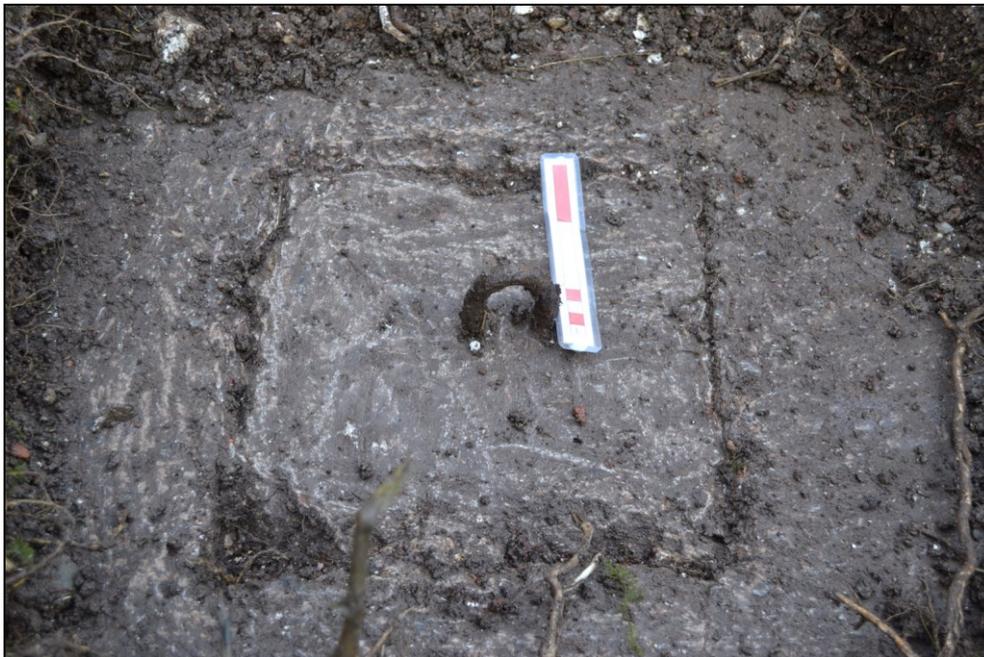
Fig. 7 Detail of the gun mounting socket

A small rectangular concrete plug with iron ring is evident in the centre of the west chamber (Fig. 7). It was not ascertained whether a similar plug was evident in the eastern chamber, due to fallen rubble from the central wall. The concrete plug has been interpreted as a mounting plug or cover that was used to protect a gun mounting when not in use. This would have been removed when the light anti-aircraft gun was inserted into its mounting socket.

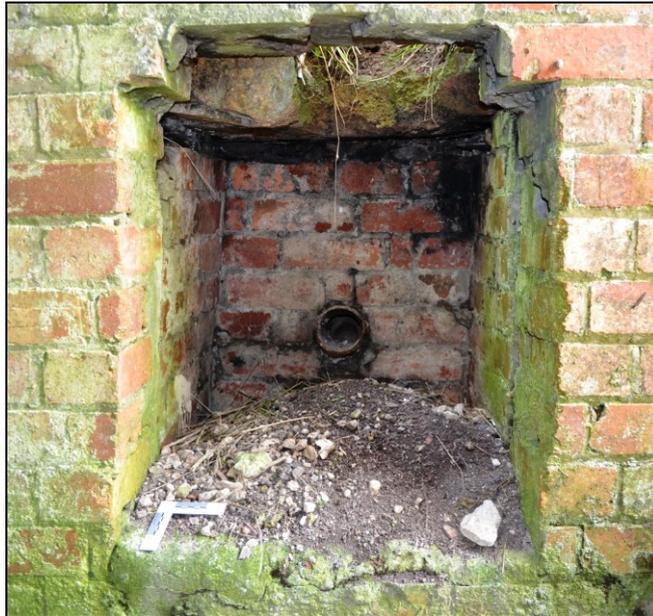
Fig. 8 Fire place in the blast shelter showing air in-let pipe and boiler plate

The floor of the shelter is also made of concrete and there is a soak-away in the north-east corner of the shelter. This soak-away measures 15 x 15 cm and is lipped indicating that a grate would have been in place. There are three other openings in the shelter: fireplace, window and slit opening. The fireplace has been inserted into the east wall of the shelter. It appears to have been inserted post initial construction of the shelter as the opening has been cut through existing brickwork and the side walls of the fireplace are not bonded with the main wall (Fig. 8). This brick fireplace measures 72 x 55 cm x 60cm deep and would have contained a stove. There are the remains of a boiler plate and the entrance of an air pipe at the back of the fireplace. The barrow mound has been dug out behind the east wall to allow the fireplace to be constructed. A gap remains which would have been where the flue pipe exited, drawing the smoke out of the stove. An air inlet pipe is visible in the ground, which would have drawn air into the back of the stove.

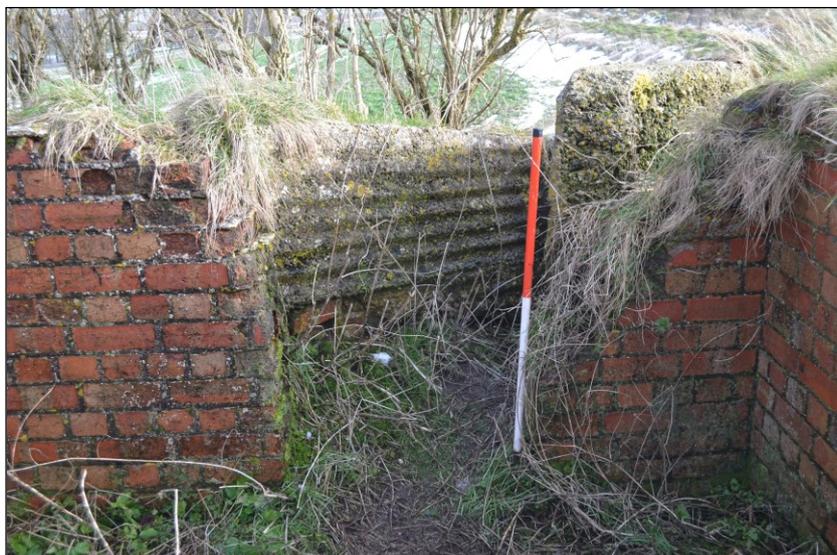
Fig. 9 View of the zig-zag blast shelter from the gun pit

The gun emplacement is accessed via a concrete lined corridor or passageway that is cut through the eastern side of the barrow, entering into the eastern chamber of the gun pit (Figs. 9 & 10). This blast entrance would have provided protected access to the emplacement and its zig-zag shape would have reduced the effects of a direct hit.

The sides of this blast entrance are made of concrete covering a brick rubble core. Corrugated iron shuttering was used to shape the concrete sides, and the grooves of this shuttering are imprinted in the concrete. The concrete lined sides have collapsed inwards in several places and the brick core has been revealed. Some of the bricks have the letters; LBC PHORPRES. These bricks are Flettons made by the London Brick Company.

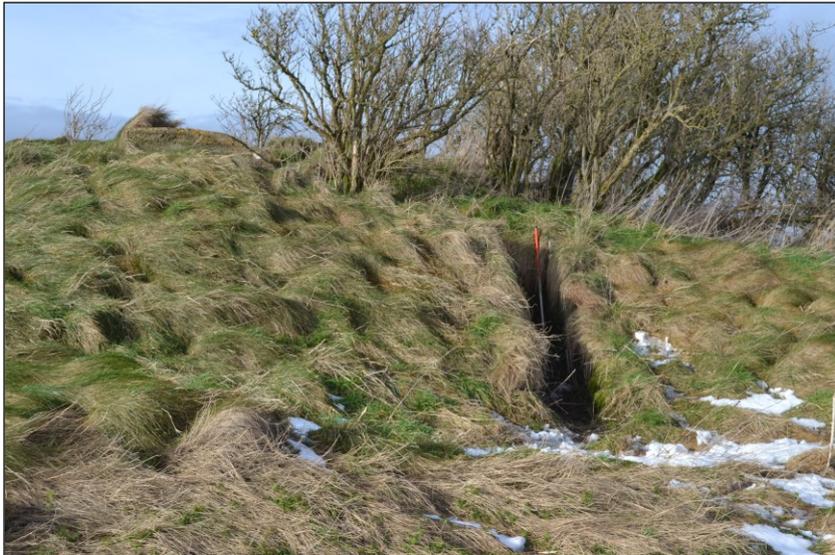
Fig. 10 View of the zig-zag blast entrance from outside the site

The concrete blast entrance is in a poor condition. Sections of the concrete rendering have collapsed inwards, revealing the rubble core beneath.

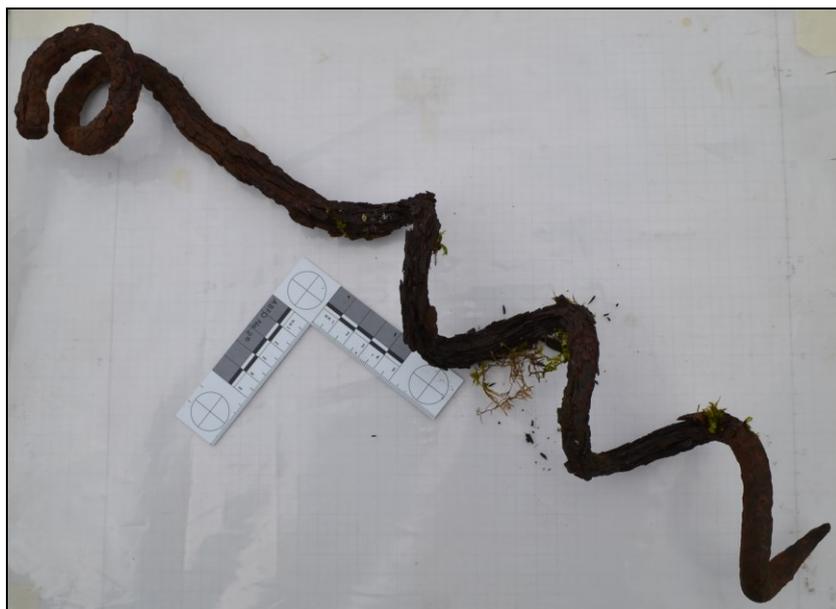
Fig. 11 Screw picket found on the northern edge of the barrow

During the recording of the gun emplacement, a number of long 4 eye screw pickets (152cm) and shorter 1 loop anchorage pickets (45 cm) and lengths of barbed wire, were found at the base of the northern side of the barrow (Fig. 11). These are corroded and are not made of galvanized metal. These pickets (main and anchorage) are standard military (First and Second World War) models. Combined with the evidence from the aerial photographs of the gun emplacement surrounded by an outer perimeter of barbed wire, it suggests that these pickets and barbed wire date to the Second World War and were used to create the protective perimeter barrier.

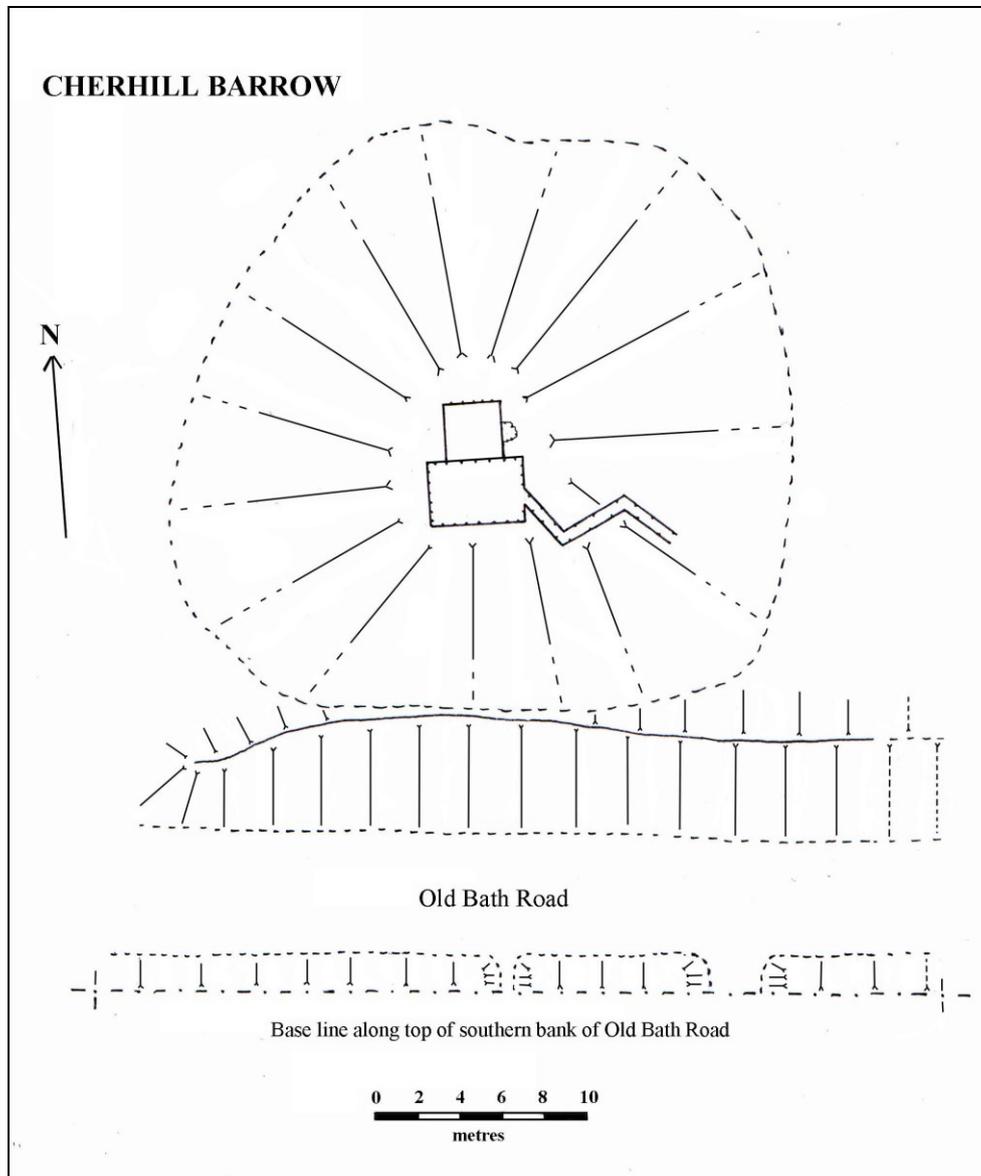
Fig. 12 Earthwork survey

The main results of the survey are illustrated in figure 12. The Old Bath Round impinges on the southern slope of the barrow and the eastern and northern slopes have been disturbed by ploughing in the adjacent fields.

The ditch which originally surrounded the barrow is no longer easily discernible on the ground and the fabric of the barrow has slumped making it difficult to locate precisely the bottom edge of the mound. However, traces of the ditch were visible on the eastern side when the site was covered in snow.

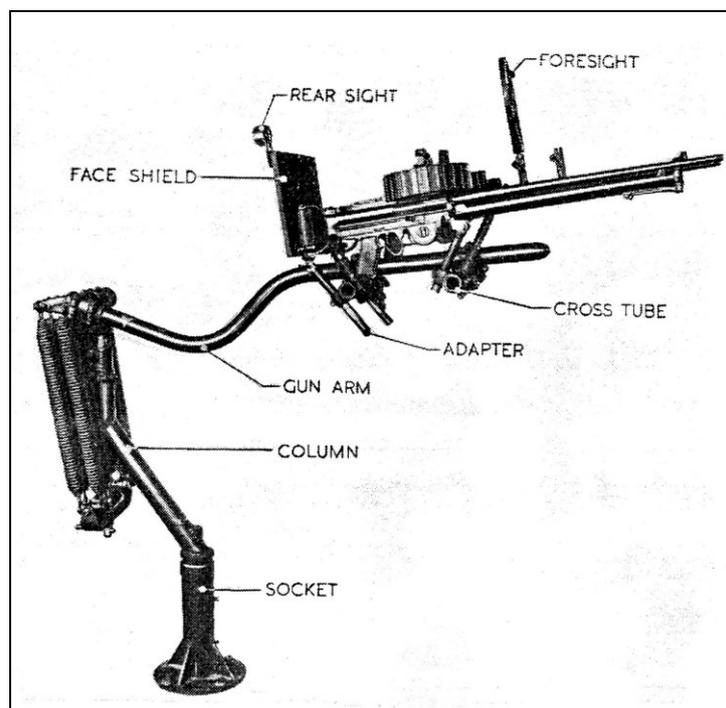
Fig. 13 Stork mount with Lewis Gun.

The type of anti-aircraft guns used is not known, though evidence of the mounting plug suggests that it would have been a light machine gun mounted on some type of stand. Two types of stand were used during the Second World War for airfield defence light anti aircraft guns; the Motley mounting for the Bren light machine gun, and the Stork type mounting for the Lewis guns (Thomas, R. 2013 pers comm). Due to the single central mounting socket, it has been suggested that the Lewis gun on a Stork type mounting may be the best interpretation for weaponry used on the site.

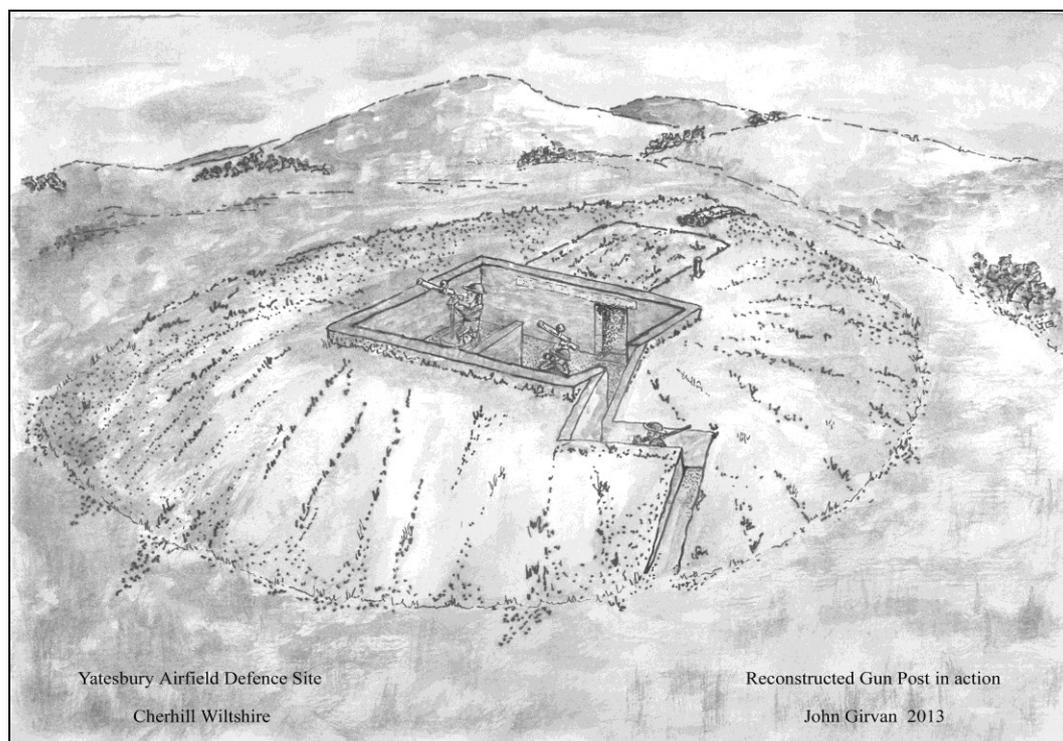
Fig. 14. Reconstruction of the gun emplacement by John Girvan

There is a small window in the northern side of the shelter looking down over the Radio School. This would have had a shutter, and has been interpreted as a signalling window rather than as an embrasure, as it does not seem to have had a defensive purpose. The gun emplacement could have had a dual function as an observation post, especially from 1943 when the threat of bombing and invasion had largely dissipated.
